Northern Gas Pipeline

Draft Environmental Impact Statement

APPENDIX L – PRELIMINARY ASSESSMENT OF GEOTECHNICAL AND SOIL LANDSCAPE MAPPING (JUNE 2016)

Preliminary Assessment of
Geotechnical and Soil Landscape Mapping

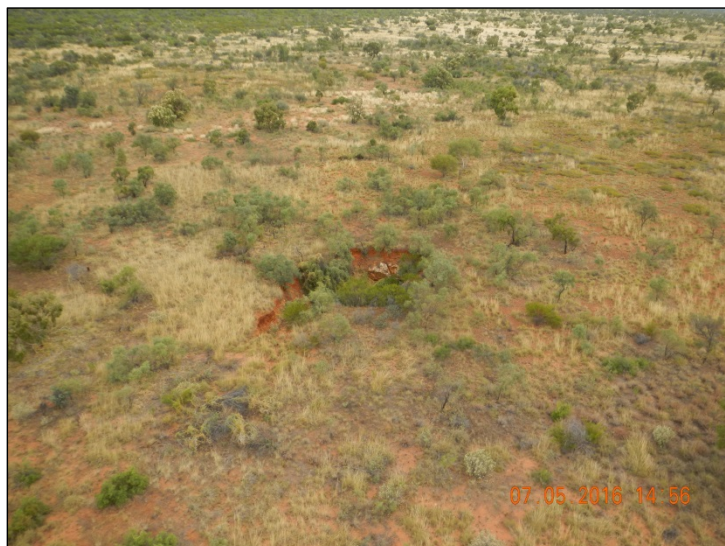
Figure 1: Photo of Sink Hole at Chainage KP257.2

It is understood that during a flyover of the alignment, a potential sink hole was observed at chainage KP 257.2 [(E:625892.00 N:7789050.00), location noted in attached KMZ file and photograph provided below in Figure 1]. It is further understood that the crew landed and confirmed that the alignment passed through the feature, and that no evidence of a 'cave in' was observed. However, in transit to the location other indications of some small 'cave-ins' in outcrops were noted.

Research of information published by the Northern Territory Geological Survey indicates that shallow solution features (sink holes) are widespread within the calcrete. This rock unit is depicted on the geological maps as a 17 km section extending south-eastwards some 20 km south-east of the Barkly Homestead (extents noted on attached KMZ file).
