## Northern Gas Pipeline

### Draft Environmental Impact Statement

#### APPENDIX K – WATERCOURSE CROSSING SURVEY REPORT

# Northern Gas Pipeline Watercourse Crossing Survey Report

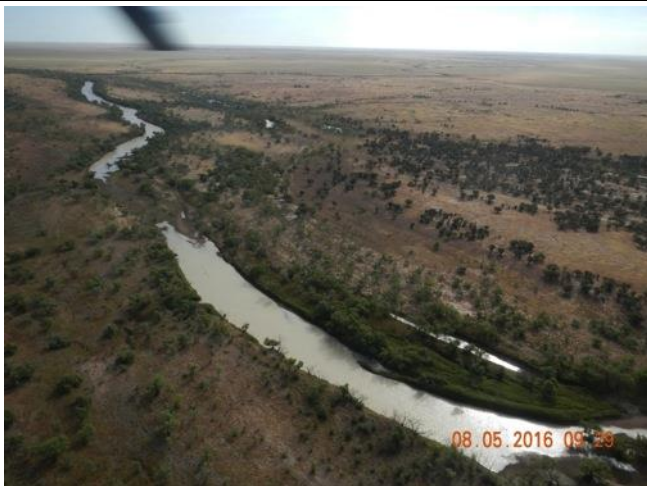
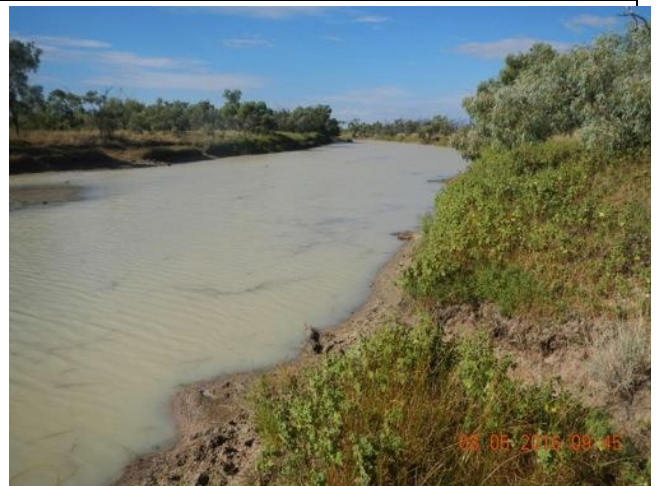
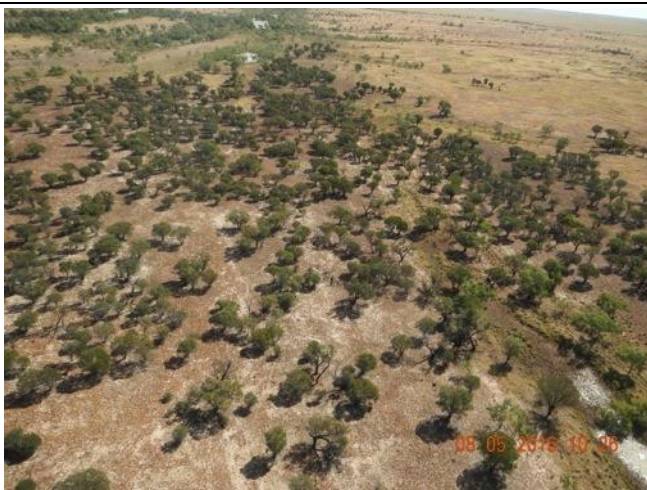
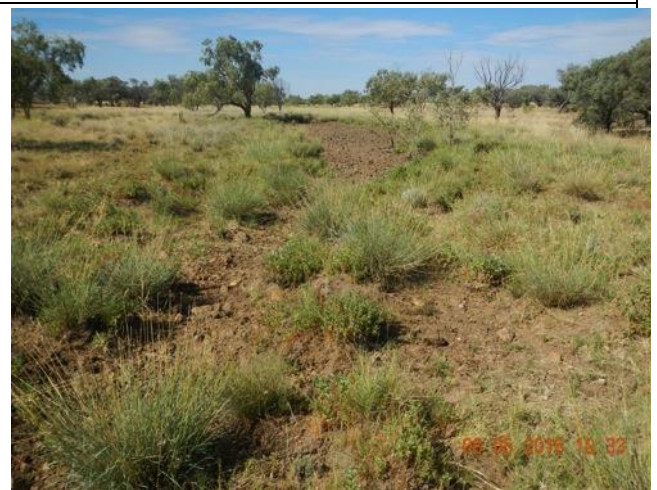
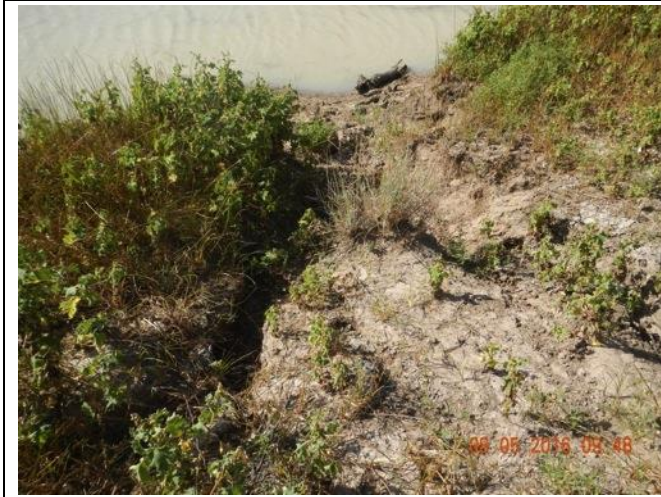
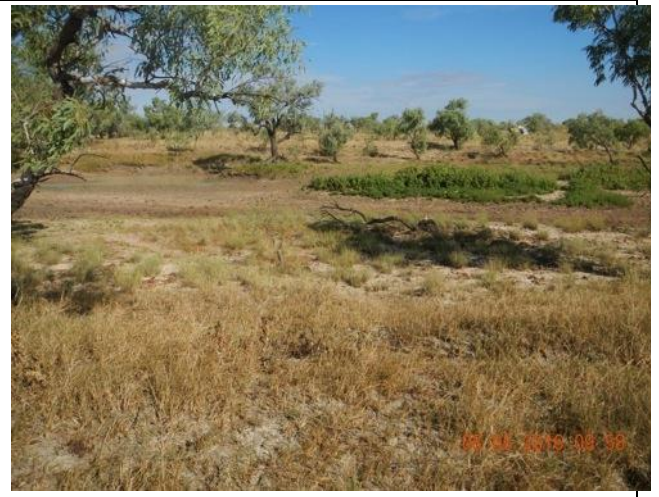
## Photos

<b>Location</b>							
<b>Site name</b>	NT Watercourse 2			<b>Location (KP)</b>	410		
<b>Watercourse name</b>	James River			<b>GPS points GDA 1994, Zone 53</b>	E 769233 N 7735528		
<b>General</b>							
<b>Stream order</b>	5+	<b>Channel type</b>	Straight	<b>No. of channels</b>	1	<b>Surrounding landform</b>	Clay plain
<b>Geometry</b>							
<b>Bank height (m)</b>	1 (west) 2 (east)	<b>Channel width (m)</b>	15	<b>Bank slope (%)</b>	See sketch	<b>Bank type</b>	Clay
<b>Bed width (m)</b>	10	<b>Bed slope (%)</b>	3	<b>Bed type</b>	Clay & mud	<b>Presence of root matter in bank or aquatic vegetation</b>	Yes Tree roots only
<b>Stability</b>							
<b>Erosion presence</b>	Yes	<b>Location</b>	Bank			<b>Type</b>	Gully
<b>Possible contributing factors</b>			Cattle			<b>Severity</b>	Moderate to high
<b>Habitat</b>							
<b>Riparian vegetation</b>	Coolabah, Sedges, Sporobolus sp., reeds						
<b>In-stream habitat</b>	Murky water, no aquatic vegetation					<b>Presence of water or signs of wetted embankment</b>	Yes

<b>Permanent water (within 1km of ROW)</b>							
<b>Presence of pool</b>	Not identified- water flowing at the time of survey			<b>Width of pool (m)</b>		<b>Depth of pool (m)</b>	
<b>Water description</b>				<b>Bank height (m)</b>		<b>Bank width (m)</b>	
<b>Bank slope</b>		<b>Bank composition</b>				<b>Vegetation presence</b>	
<b>Sketch of cross sectional profile</b>

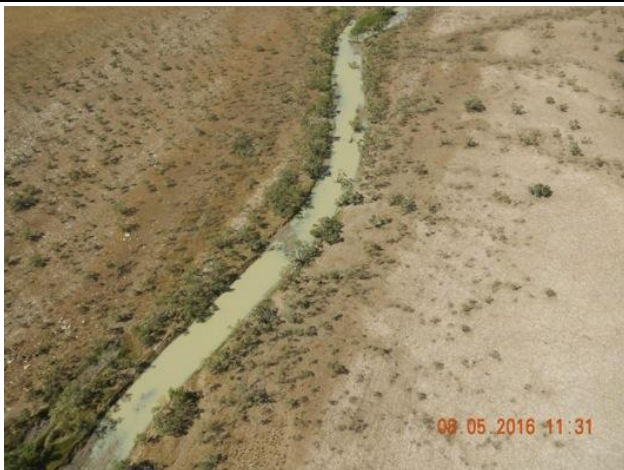
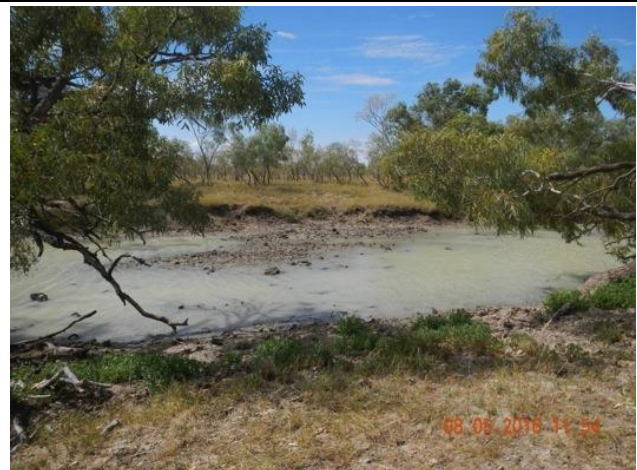
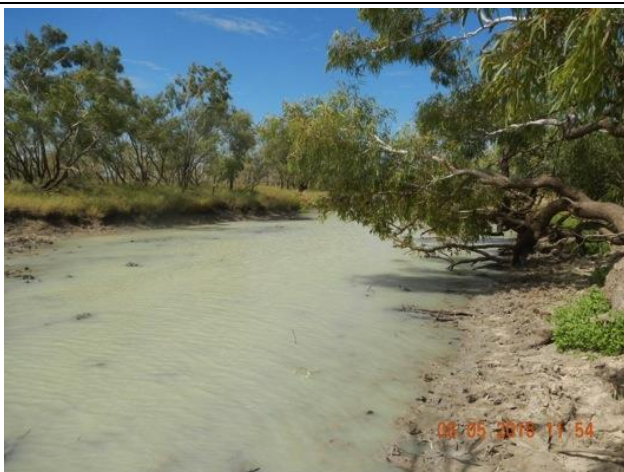
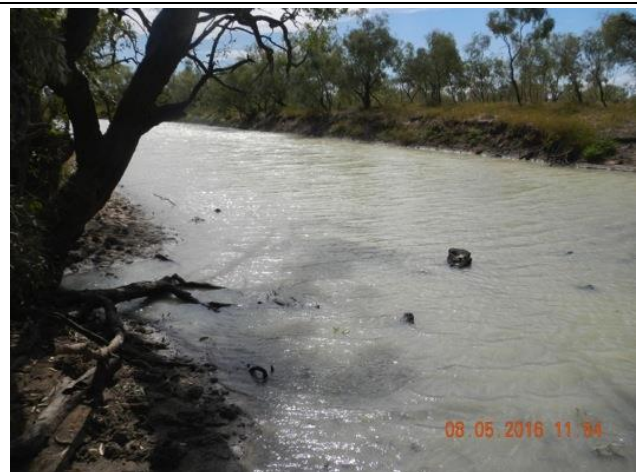
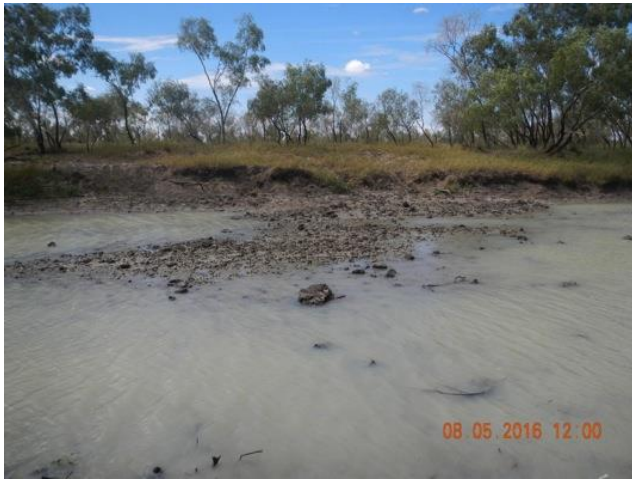
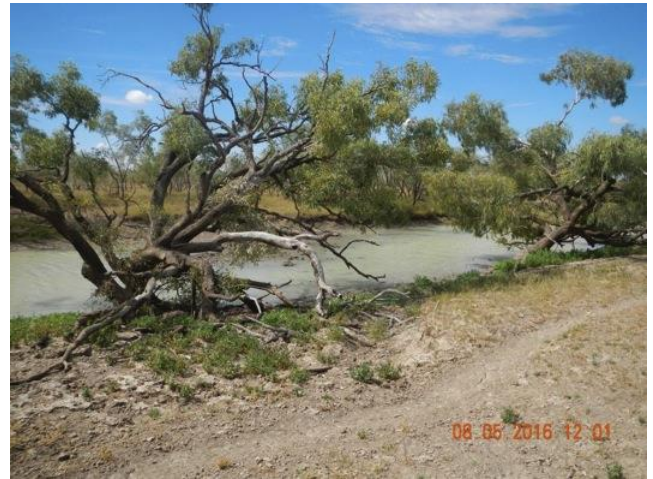
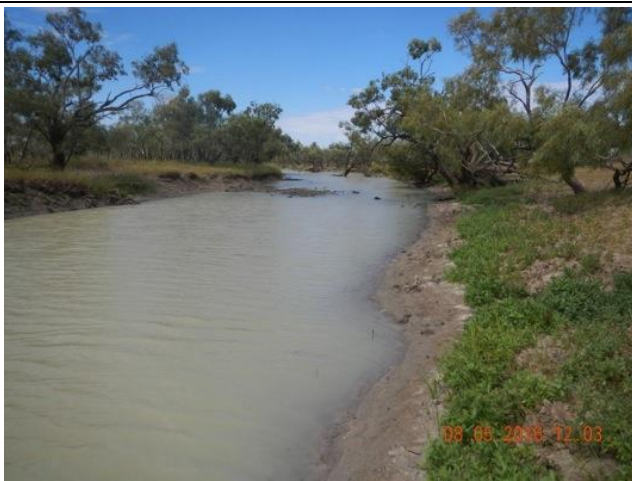
## Photos

<b>Location</b>							
<b>Site name</b>	NT Watercourse 3			<b>Location (KP)</b>		KP 424	
<b>Watercourse name</b>	Tributary of Georgina River			<b>GPS points GDA 1994, Zone 53</b>		E 781700 N 7730490	
<b>General</b>							
<b>Stream order</b>	3	<b>Channel type</b>	Straight	<b>No. of channels</b>	1	<b>Surrounding landform</b>	Clay plains
<b>Geometry</b>							
<b>Bank height (m)</b>	0.5	<b>Channel width (m)</b>	7 no distinct channel	<b>Bank slope (%)</b>	10	<b>Bank type</b>	Clay, gravel Not distinct
<b>Bed width (m)</b>	3 - 5	<b>Bed slope (%)</b>	2	<b>Bed type</b>	Clay	<b>Presence of root matter in bank or aquatic vegetation</b>	
<b>Stability</b>							
<b>Erosion presence</b>	No	<b>Location</b>	N/A		<b>Type</b>	N/A	
<b>Possible contributing factors</b>			N/A			<b>Severity</b>	N/A
<b>Habitat</b>							
<b>Riparian vegetation</b>	No riparian vegetation, tussock grass & Mesquite ( <i>Prosopis pallida</i> ) shrubs (significant weed)

<b>In-stream habitat</b>	N/A tussock grass					<b>Presence of water or signs of wetted embankment</b>	No
<b>Permanent water (within 1km of ROW)</b>							
<b>Presence of pool</b>	No	<b>Proximity to ROW crossing (m)</b>		<b>Width of pool (m)</b>		<b>Depth of pool (m)</b>	
<b>Water description</b>				<b>Bank height (m)</b>		<b>Bank width (m)</b>	
<b>Bank slope</b>		<b>Bank composition</b>				<b>Vegetation presence</b>	
<b>Sketch of cross sectional profile</b>

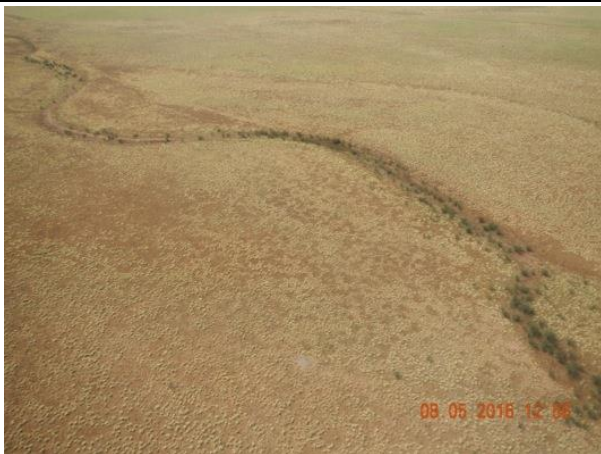
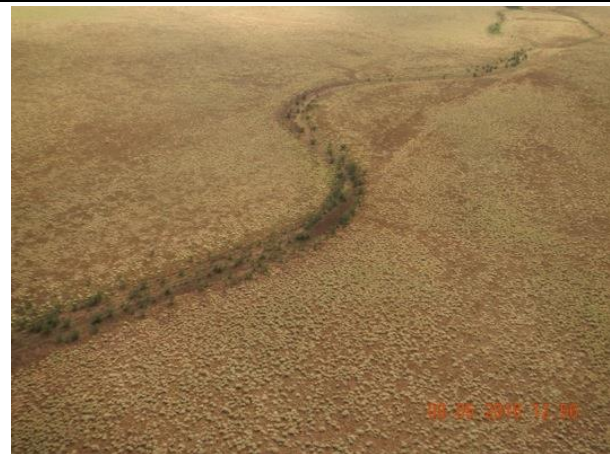
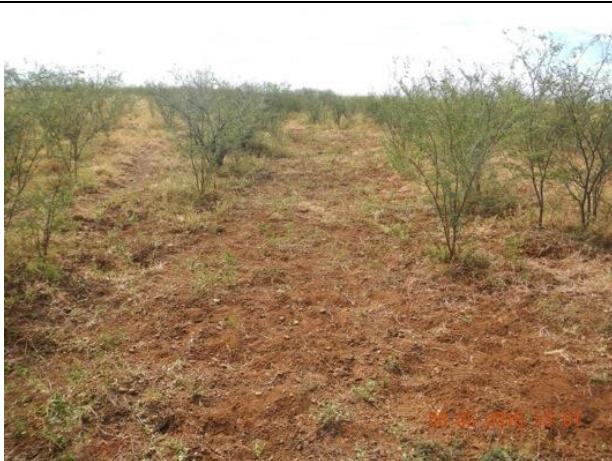
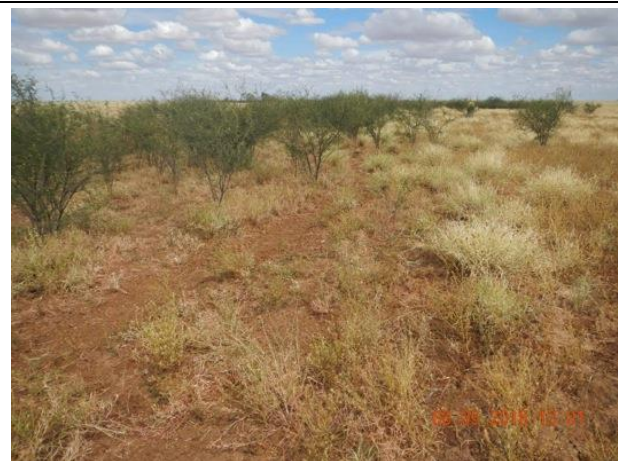
#### Photos

<b>Location</b>							
<b>Site name</b>	NT Watercourse 4			<b>Location (KP)</b>		431	
<b>Watercourse name</b>	Georgina River			<b>GPS points GDA 1994, Zone 53</b>		E 788219 N 7727078	
<b>General</b>							
<b>Stream order</b>	5+	<b>Channel type</b>	Meandering river	<b>No. of channels</b>	1 (three minor/small tributaries)	<b>Surrounding landform</b>	Clay plains
<b>Geometry</b>							
<b>Bank height (m)</b>	2.5 - 3	<b>Channel width (m)</b>	26	<b>Bank slope (%)</b>	See sketch	<b>Bank type</b>	Clay mud
<b>Bed width (m)</b>	16	<b>Bed slope (%)</b>	2 south aspect	<b>Bed type</b>	Fine sand clays	<b>Presence of root matter in bank or aquatic vegetation</b>	No
<b>Stability</b>							
<b>Erosion presence</b>	Yes	<b>Location</b>	Banks			<b>Type</b>	Gully
<b>Possible contributing factors</b>			Cattle			<b>Severity</b>	Moderate to high
<b>Habitat</b>							
<b>Riparian vegetation</b>	Coolabah lined banks, Mitchell Grass ( <i>Astrebla</i> sp.), <i>Sporobolus</i> sp., Pigface, Couch Grass (weed)

<b>In-stream habitat</b>	Some small outcrop, murky water (light yellow-brown), fallen logs					<b>Presence of water or signs of wetted embankment</b>	Yes
<b>Permanent water (within 1km of ROW)</b>							
<b>Presence of pool</b>	Not identified- water flowing at the time of survey				<b>Width of pool (m)</b>		<b>Depth of pool (m)</b>
<b>Water description</b>					<b>Bank height (m)</b>		<b>Bank width (m)</b>
<b>Bank slope</b>		<b>Bank composition</b>					<b>Vegetation presence</b>
<b>General notes</b>							
Impact by cattle significant							
<b>Sketch of cross sectional profile</b>

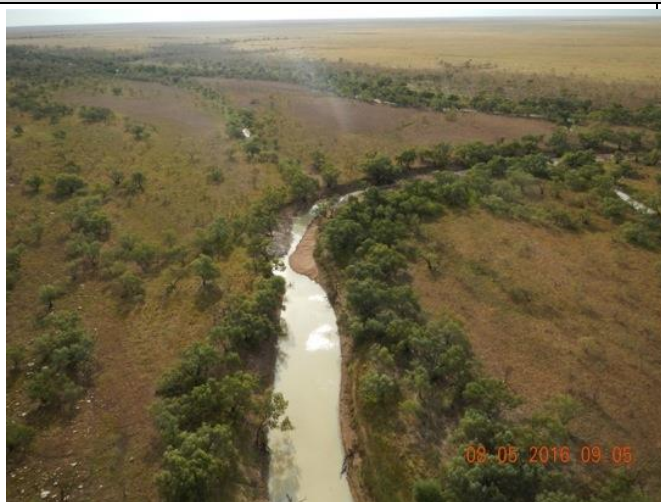
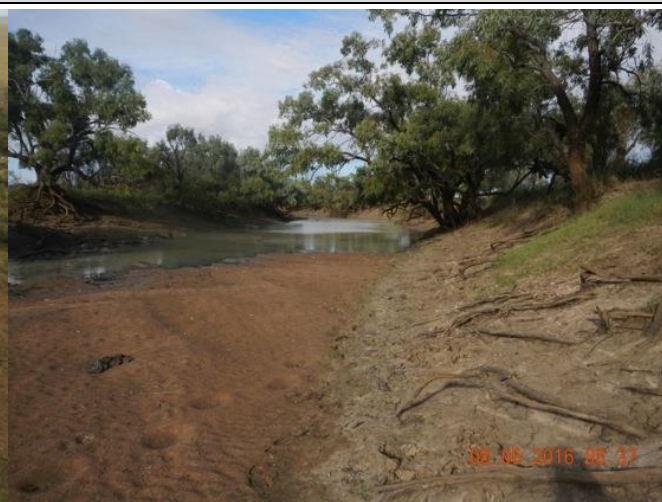
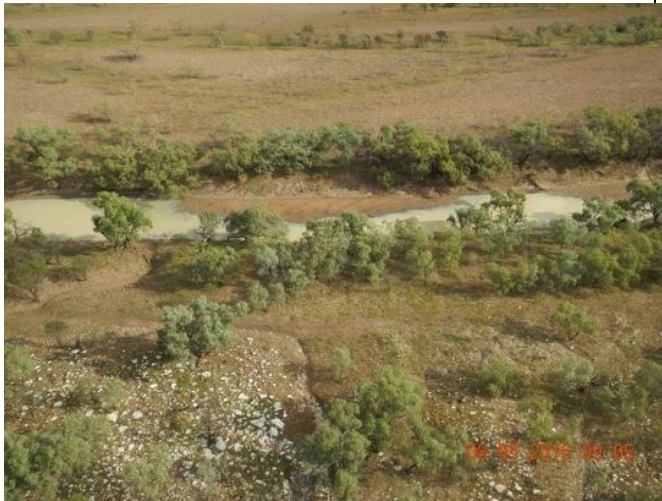
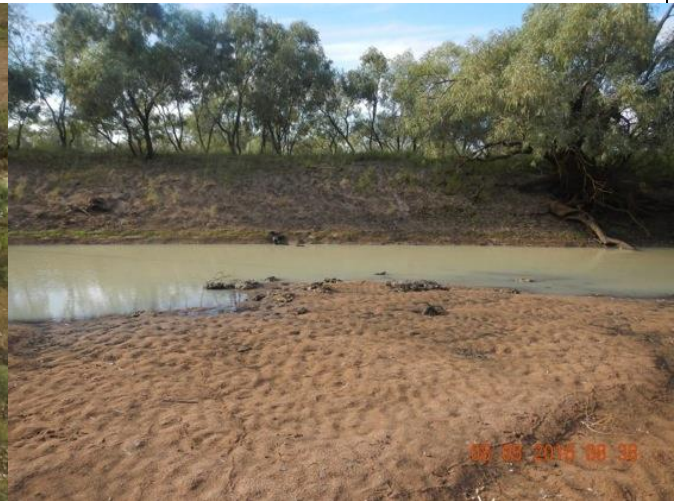
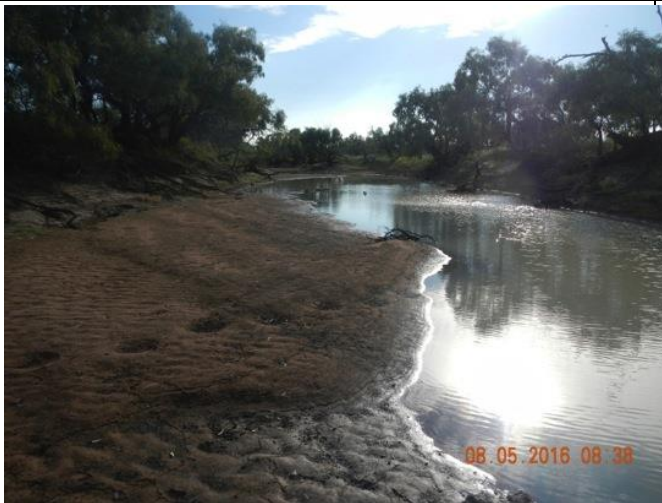
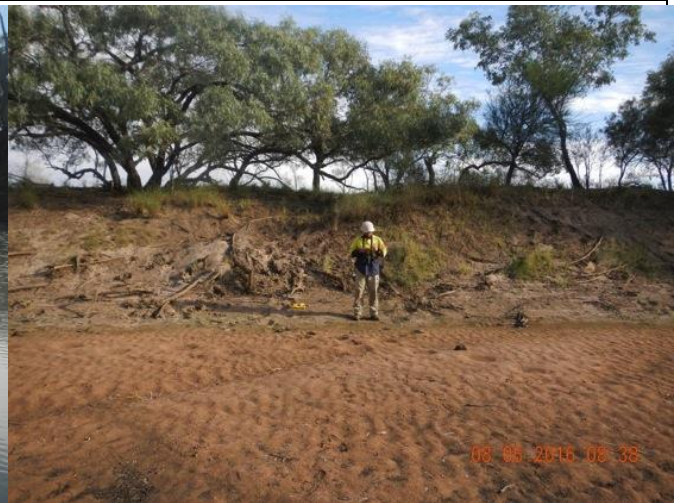
## Photos

<b>Location</b>							
<b>Site name</b>	NT Watercourse 5			<b>Location (KP)</b>		443	
<b>Watercourse name</b>	Tributary of Blue Bush Creek			<b>GPS points GDA 1994, Zone 53</b>		E 799311 N 7722783	
<b>General</b>							
<b>Stream order</b>	3	<b>Channel type</b>	Straight	<b>No. of channels</b>	1	<b>Surrounding landform</b>	Clay plain
<b>Geometry</b>							
<b>Bank height (m)</b>	0.5	<b>Channel width (m)</b>	5	<b>Bank slope (%)</b>	5	<b>Bank type</b>	Clay
<b>Bed width (m)</b>	1	<b>Bed slope (%)</b>	1	<b>Bed type</b>	Clay	<b>Presence of root matter in bank or aquatic vegetation</b>	No
<b>Stability</b>							
<b>Erosion presence</b>	No	<b>Location</b>	N/A		<b>Type</b>	N/A	
<b>Possible contributing factors</b>			N/A			<b>Severity</b>	N/A
<b>Habitat</b>							
<b>Riparian vegetation</b>	Lined with Lignum ( <i>Muehlenbeckia florulenta</i> ) (noted as unknown shrub in cross-section sketch)						
<b>In-stream habitat</b>	No				<b>Presence of water or signs of wetted embankment</b>		No

<b>Permanent water (within 1km of ROW)</b>							
<b>Presence of pool</b>	No	<b>Proximity to ROW crossing (m)</b>		<b>Width of pool (m)</b>		<b>Depth of pool (m)</b>	
<b>Water description</b>				<b>Bank height (m)</b>		<b>Bank width (m)</b>	
<b>Bank slope</b>		<b>Bank composition</b>				<b>Vegetation presence</b>	
<b>Sketch of cross sectional profile</b>

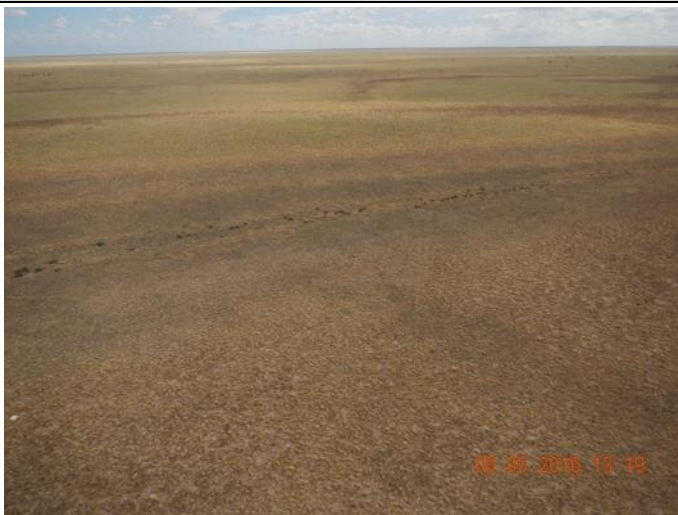
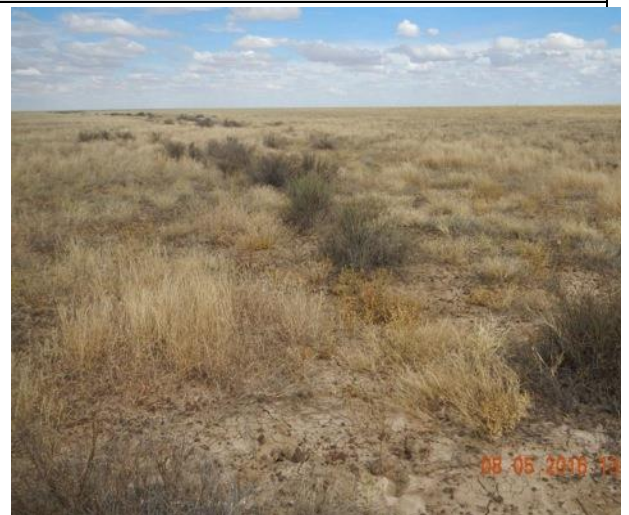
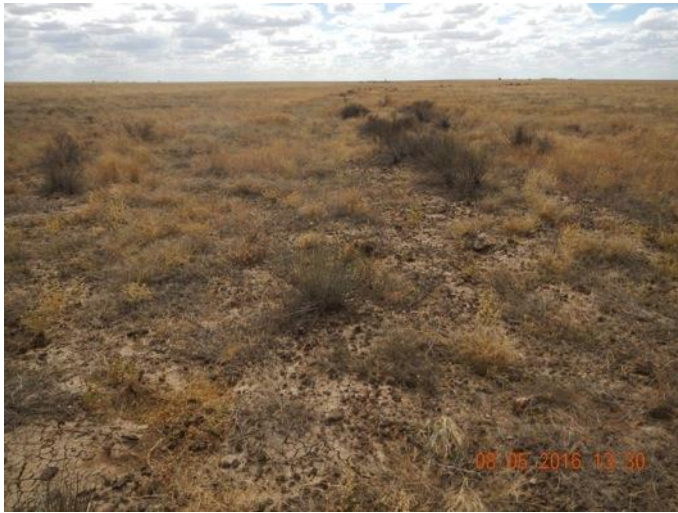
#### Photos

<b>Location</b>							
<b>Site name</b>	NT Watercourse 6				<b>Location (KP)</b>		451
<b>Watercourse name</b>	Blue Bush Creek				<b>GPS points GDA 1994, Zone 53</b>		E 806655 N 7719505
<b>General</b>							
<b>Stream order</b>	4	<b>Channel type</b>	Meandering	<b>No. of channels</b>	1	<b>Surrounding landform</b>	Clay plains
<b>Geometry</b>							
<b>Bank height (m)</b>		<b>Channel width (m)</b>	20	<b>Bank slope (%)</b>	20 west 40 east	<b>Bank type</b>	Clay stepped
<b>Bed width (m)</b>	8	<b>Bed slope (%)</b>	2	<b>Bed type</b>	Sand & clay (patchy)	<b>Presence of root matter in bank or aquatic vegetation</b>	Grass
<b>Stability</b>							
<b>Erosion presence</b>	No	<b>Location</b>	N/A			<b>Type</b>	N/A
<b>Possible contributing factors</b>			N/A			<b>Severity</b>	N/A
<b>Habitat</b>							
<b>Riparian vegetation</b>	Coolabah, Bluebush ( <i>Chenopodium auricomum</i> )						
<b>In-stream habitat</b>	No water at crossing. Freshwater crab, muscle, snail					<b>Presence of water or signs of wetted embankment</b>	Yes

<b>Permanent water (within 1km of ROW)</b>							
<b>Presence of pool</b>	Yes	<b>Proximity to ROW crossing (m)</b>		<b>Width of pool (m)</b>		<b>Depth of pool (m)</b>	
<b>Water description</b>				<b>Bank height (m)</b>		<b>Bank width (m)</b>	
<b>Bank slope</b>		<b>Bank composition</b>					<b>Vegetation presence</b>
<b>Sketch of cross sectional profile</b>

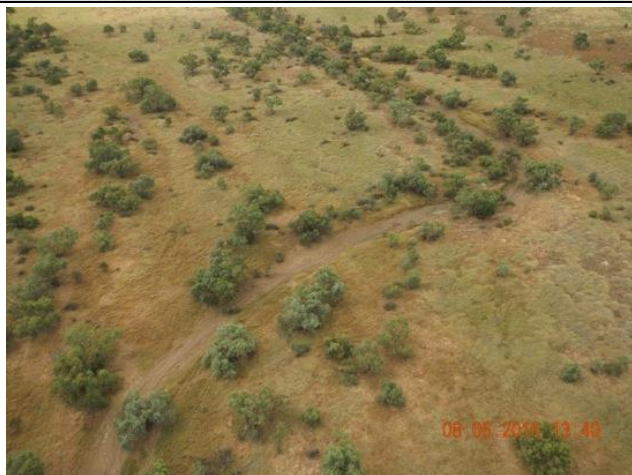
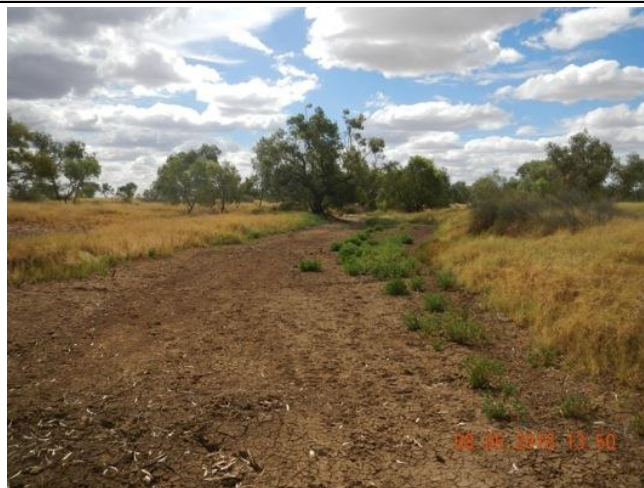
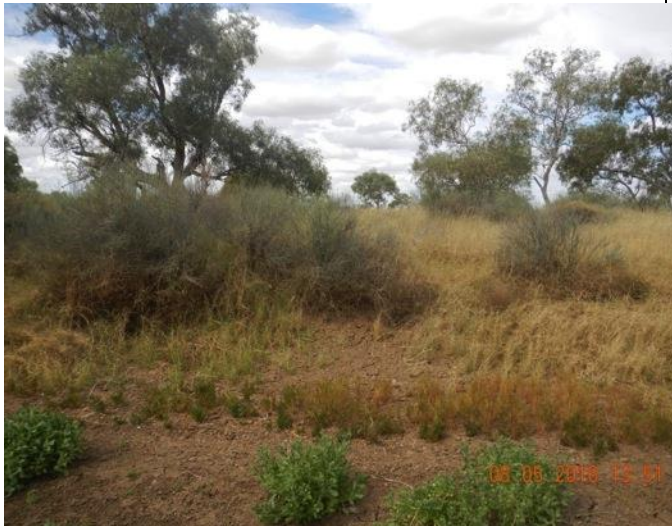
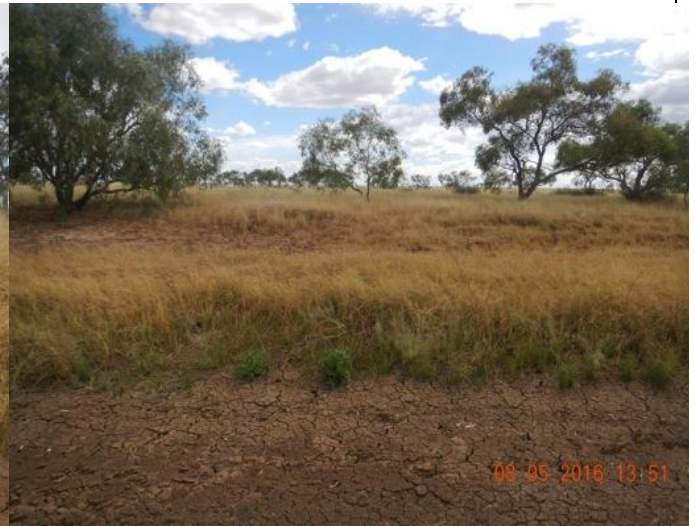
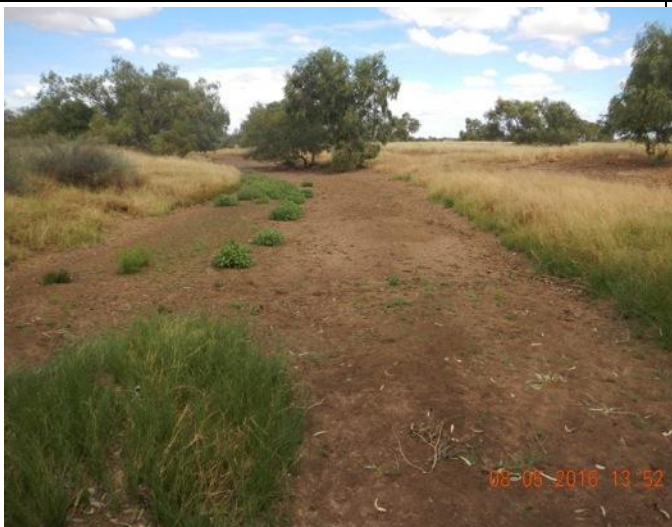
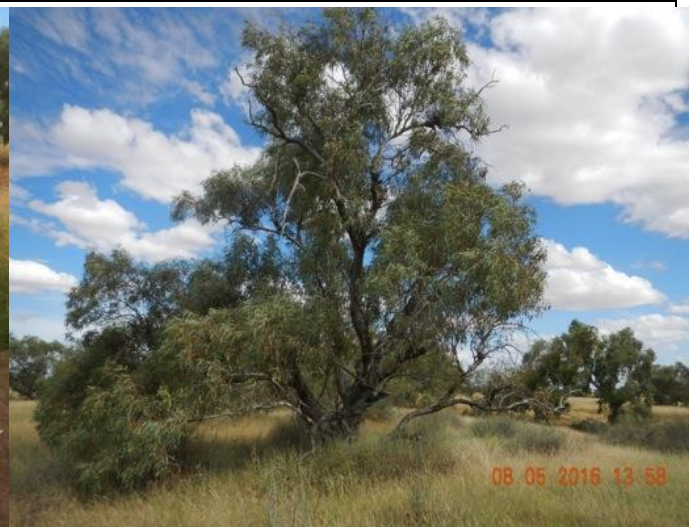
#### Photos

<b>Location</b>							
<b>Site name</b>	Queensland Watercourse 1				<b>Location (KP)</b>	465	
<b>Watercourse name</b>	Redbank Creek				<b>GPS points GDA 1994, Zone 54</b>	E 0193728 N 7715565	
<b>General</b>							
<b>Stream order</b>	4	<b>Channel type</b>	Defined	<b>No. of channels</b>	1	<b>Surrounding landform</b>	Rocky plains
<b>Geometry – N/A aerial survey only</b>							
<b>Bank height (m)</b>		<b>Channel width (m)</b>		<b>Bank slope (%)</b>		<b>Bank type</b>	
<b>Bed width (m)</b>		<b>Bed slope (%)</b>		<b>Bed type</b>		<b>Presence of root matter in bank or aquatic vegetation</b>	
<b>Stability – N/A aerial survey only</b>							
<b>Erosion presence</b>	No	<b>Location</b>				<b>Type</b>	
<b>Possible contributing factors</b>						<b>Severity</b>	
<b>Habitat – N/A aerial survey only</b>							
<b>Riparian vegetation</b>							
<b>In-stream habitat</b>						<b>Presence of water or signs of wetted embankment</b>

<b>Permanent water (within 1km of ROW)</b>							
<b>Presence of pool</b>	Yes	<b>Proximity to ROW crossing (m)</b>	400		<b>Width of pool (m)</b>	10	<b>Depth of pool (m)</b>
<b>Location</b>					<b>Location description</b>	North of ROW	
<b>Water description</b>	Brown				<b>Bank height (m)</b>		<b>Bank width (m)</b>
<b>Bank slope</b>		<b>Bank composition</b>	Mud			<b>Vegetation presence</b>	Yes
<b>General notes</b>							
Swamp >1 km north of ROW – dry. Area was checked for fringing reeds which could indicate suitable Yellow Chat habitat. None were found. 10 x 40 m pool in water course. Cattle tracks to water Eucalypts / Tussock Grass							
<b>Sketch of cross sectional profile</b>							
No sketch							
<b>Photos</b>

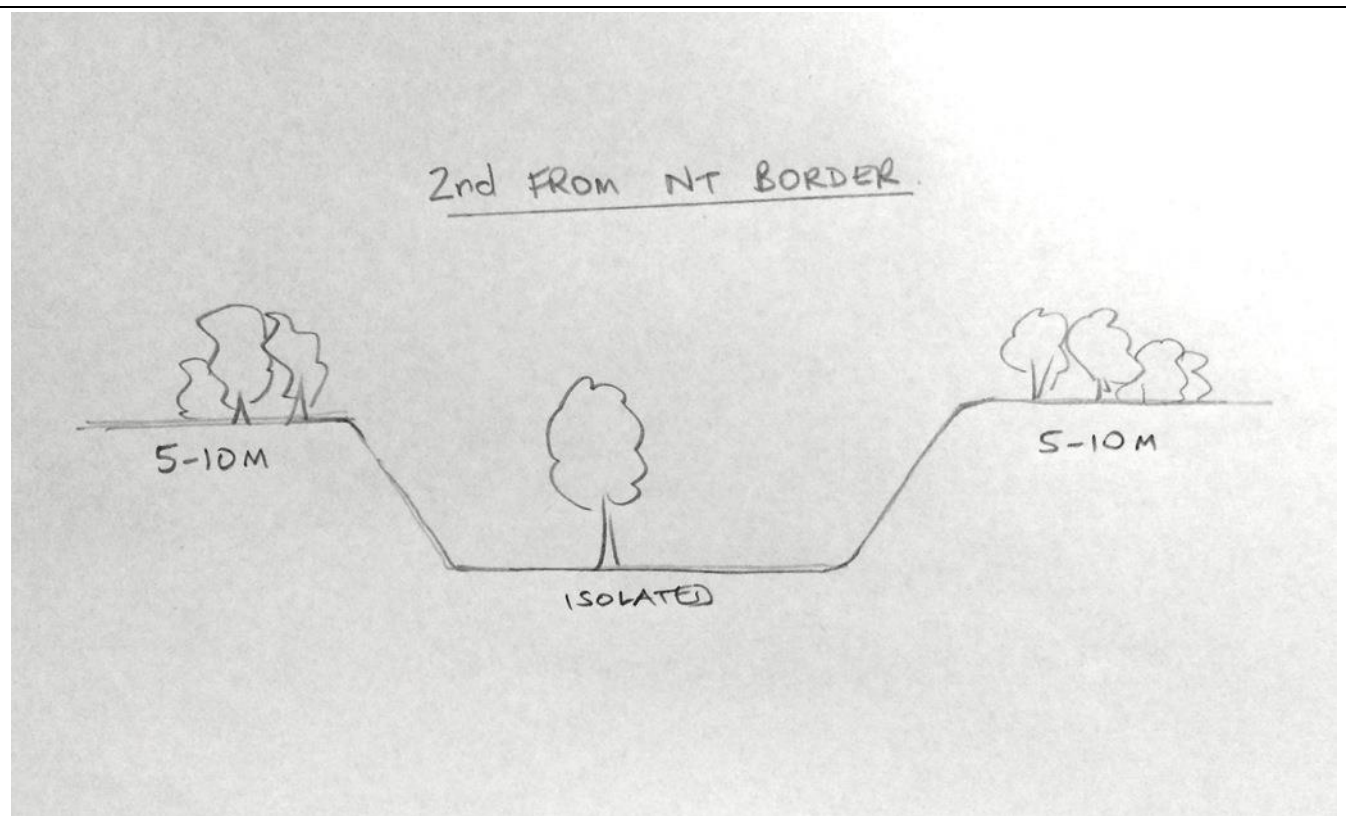
<b>Location</b>							
<b>Site name</b>	Queensland Watercourse 2 (2 <sup>nd</sup> from NT border)				<b>Location (KP)</b>	472	
<b>Watercourse name</b>	Mingera Creek				<b>GPS points GDA 1994, Zone 54</b>	E 0200854 N 7714034	
<b>General</b>							
<b>Stream order</b>	5+	<b>Channel type</b>	Single	<b>No. of channels</b>	1	<b>Surrounding landform</b>	Grassland
<b>Geometry</b>							
<b>Bank height (m)</b>	~ 2	<b>Channel width (m)</b>		<b>Bank slope (%)</b>	~ 60	<b>Bank type</b>	Mud / earth
<b>Bed width (m)</b>	18	<b>Bed slope (%)</b>	-	<b>Bed type</b>	Mud / gravel	<b>Presence of root matter in bank or aquatic vegetation</b>	
<b>Stability</b>							
<b>Erosion presence</b>	Yes	<b>Location</b>	All			<b>Type</b>	
<b>Possible contributing factors</b>			Cattle			<b>Severity</b>	Medium
<b>Habitat</b>							
<b>Riparian vegetation</b>	River Red Gum, Gidgee, Castor Oil Plant (weed), Buffel Grass (weed)						
<b>In-stream habitat</b>	Roots					<b>Presence of water or signs of wetted embankment</b>	Yes

<b>Permanent water (within 1km of ROW)</b>							
<b>Presence of pool</b>	No	<b>Proximity to ROW crossing (m)</b>		<b>Width of pool (m)</b>		<b>Depth of pool (m)</b>	
<b>Water description</b>					<b>Bank height (m)</b>		<b>Bank width (m)</b>
<b>Bank slope</b>		<b>Bank composition</b>					<b>Vegetation presence</b>
<b>General notes</b>							
Cracking clay surrounding. Cattle impact widespread. Standing water from recent rain – no permanent waterbody 2 <sup>nd</sup> small channel to east.							
<b>Sketch of cross sectional profile</b>

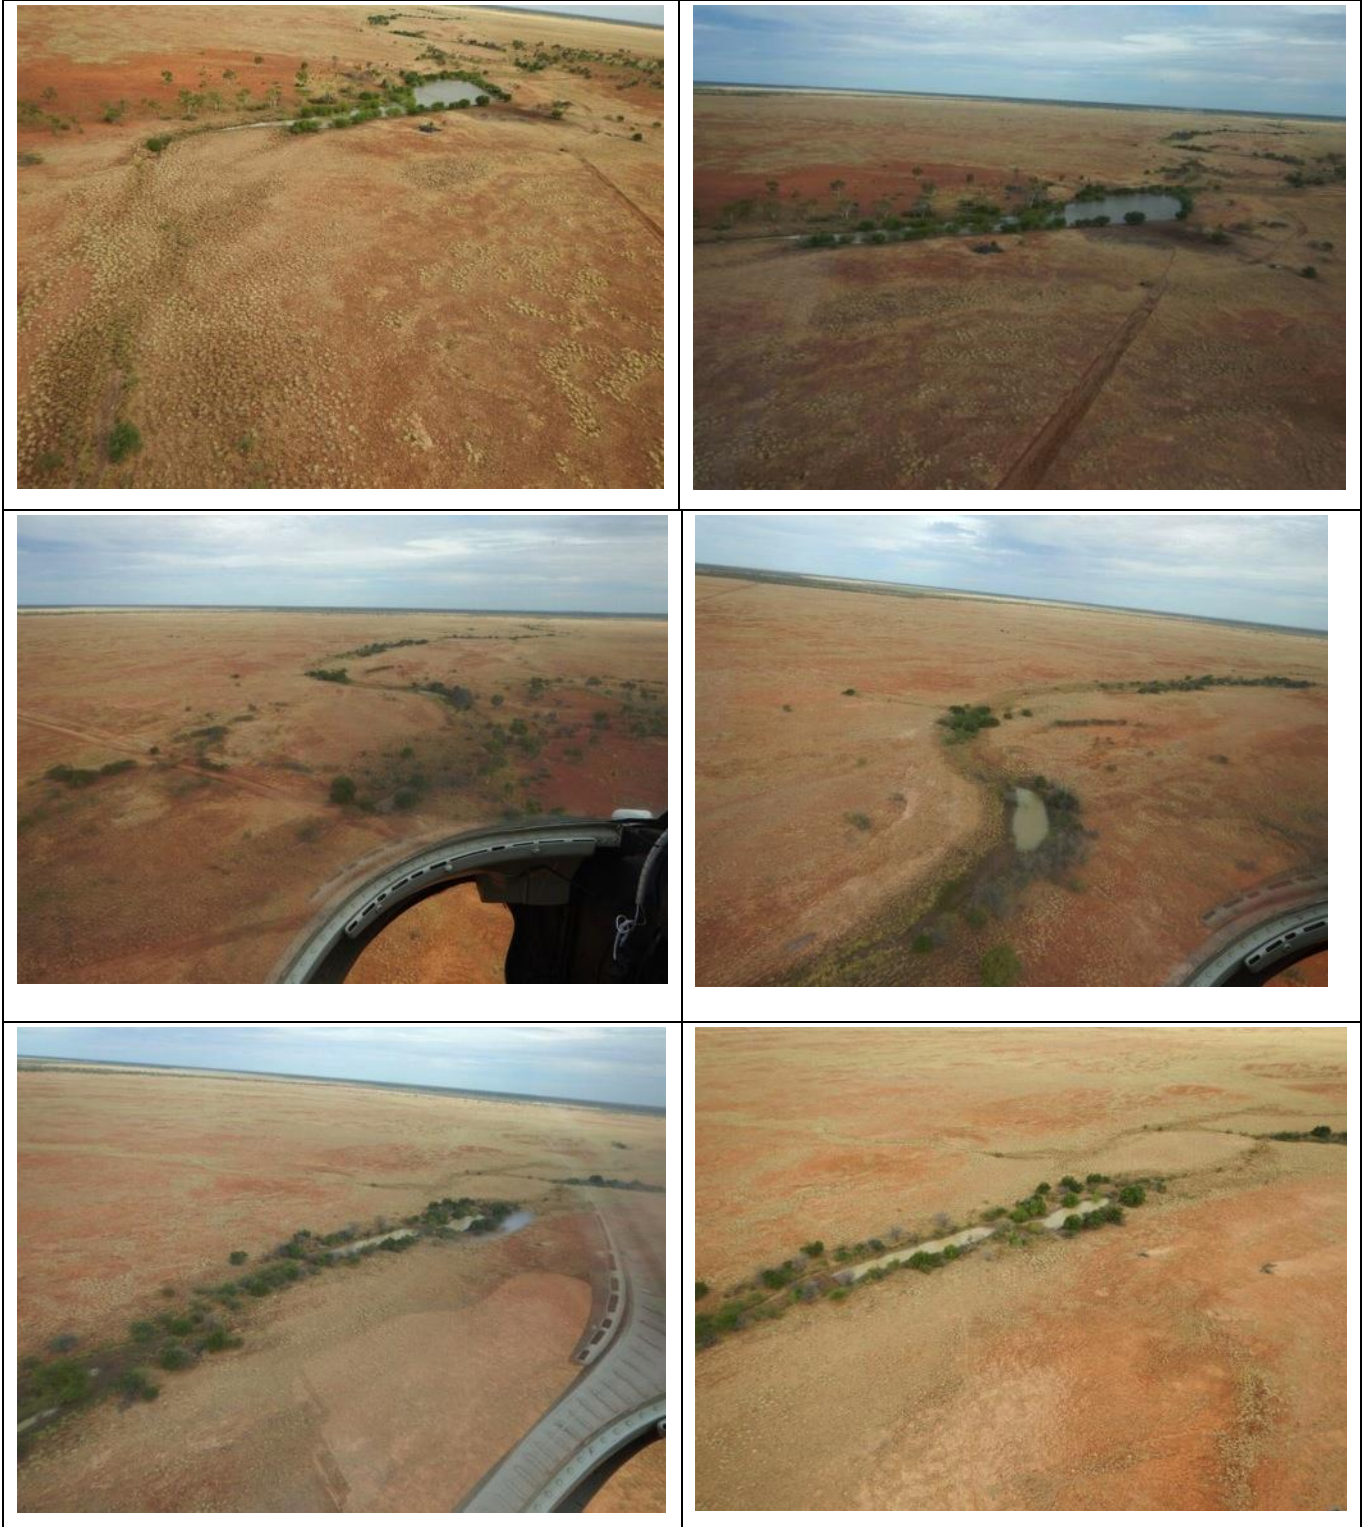
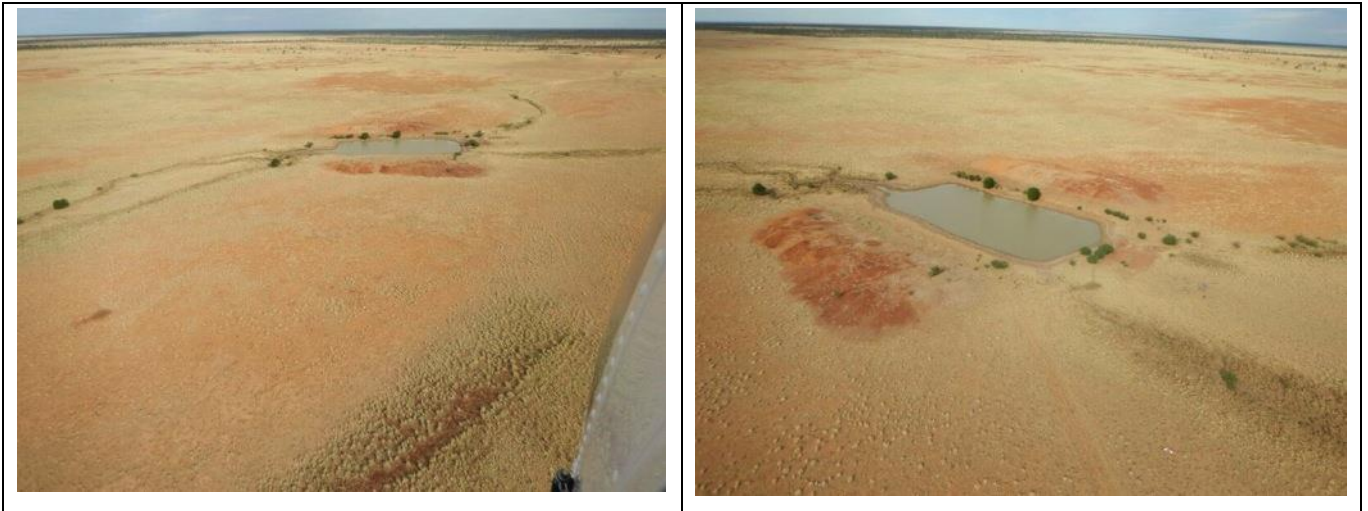
<b>Location</b>							
<b>Site name</b>	Queensland Watercourse 3			<b>Location (KP)</b>	506		
<b>Watercourse name</b>	Unnamed – tributary of Polygonum Creek			<b>GPS points GDA 1994, Zone 54</b>	E 0234887 N 7707907		
<b>General</b>							
<b>Stream order</b>	1	<b>Channel type</b>	Single	<b>No. of channels</b>	1	<b>Surrounding landform</b>	Rocky plain
<b>Geometry– N/A aerial survey only</b>							
<b>Bank height (m)</b>		<b>Channel width (m)</b>		<b>Bank slope (%)</b>		<b>Bank type</b>	
<b>Bed width (m)</b>		<b>Bed slope (%)</b>		<b>Bed type</b>		<b>Presence of root matter in bank or aquatic vegetation</b>	
<b>Stability– N/A aerial survey only</b>							
<b>Erosion presence</b>		<b>Location</b>				<b>Type</b>	
<b>Possible contributing factors</b>						<b>Severity</b>	
<b>Habitat– N/A aerial survey only</b>							
<b>Riparian vegetation</b>							
<b>In-stream habitat</b>						<b>Presence of water or signs of wetted embankment</b>

<b>Permanent water (within 1km of ROW)</b>							
<b>Presence of pool</b>	Yes	<b>Proximity to ROW crossing (m)</b>	~ 50 m		<b>Width of pool (m)</b>		<b>Depth of pool (m)</b>
<b>Water description</b>	Artificial dam				<b>Bank height (m)</b>		<b>Bank width (m)</b>
<b>Bank slope</b>		<b>Bank composition</b>					<b>Vegetation presence</b>
<b>General notes</b>							
<p><i>Parkinsonia aculeata.</i></p> <p>Some remnant pools in watercourse – unlikely to remain throughout dry season.</p> <p>Man-made dam close to ROW.</p>							
<b>Sketch of cross sectional profile</b>							
No sketch							
<b>Photos</b>

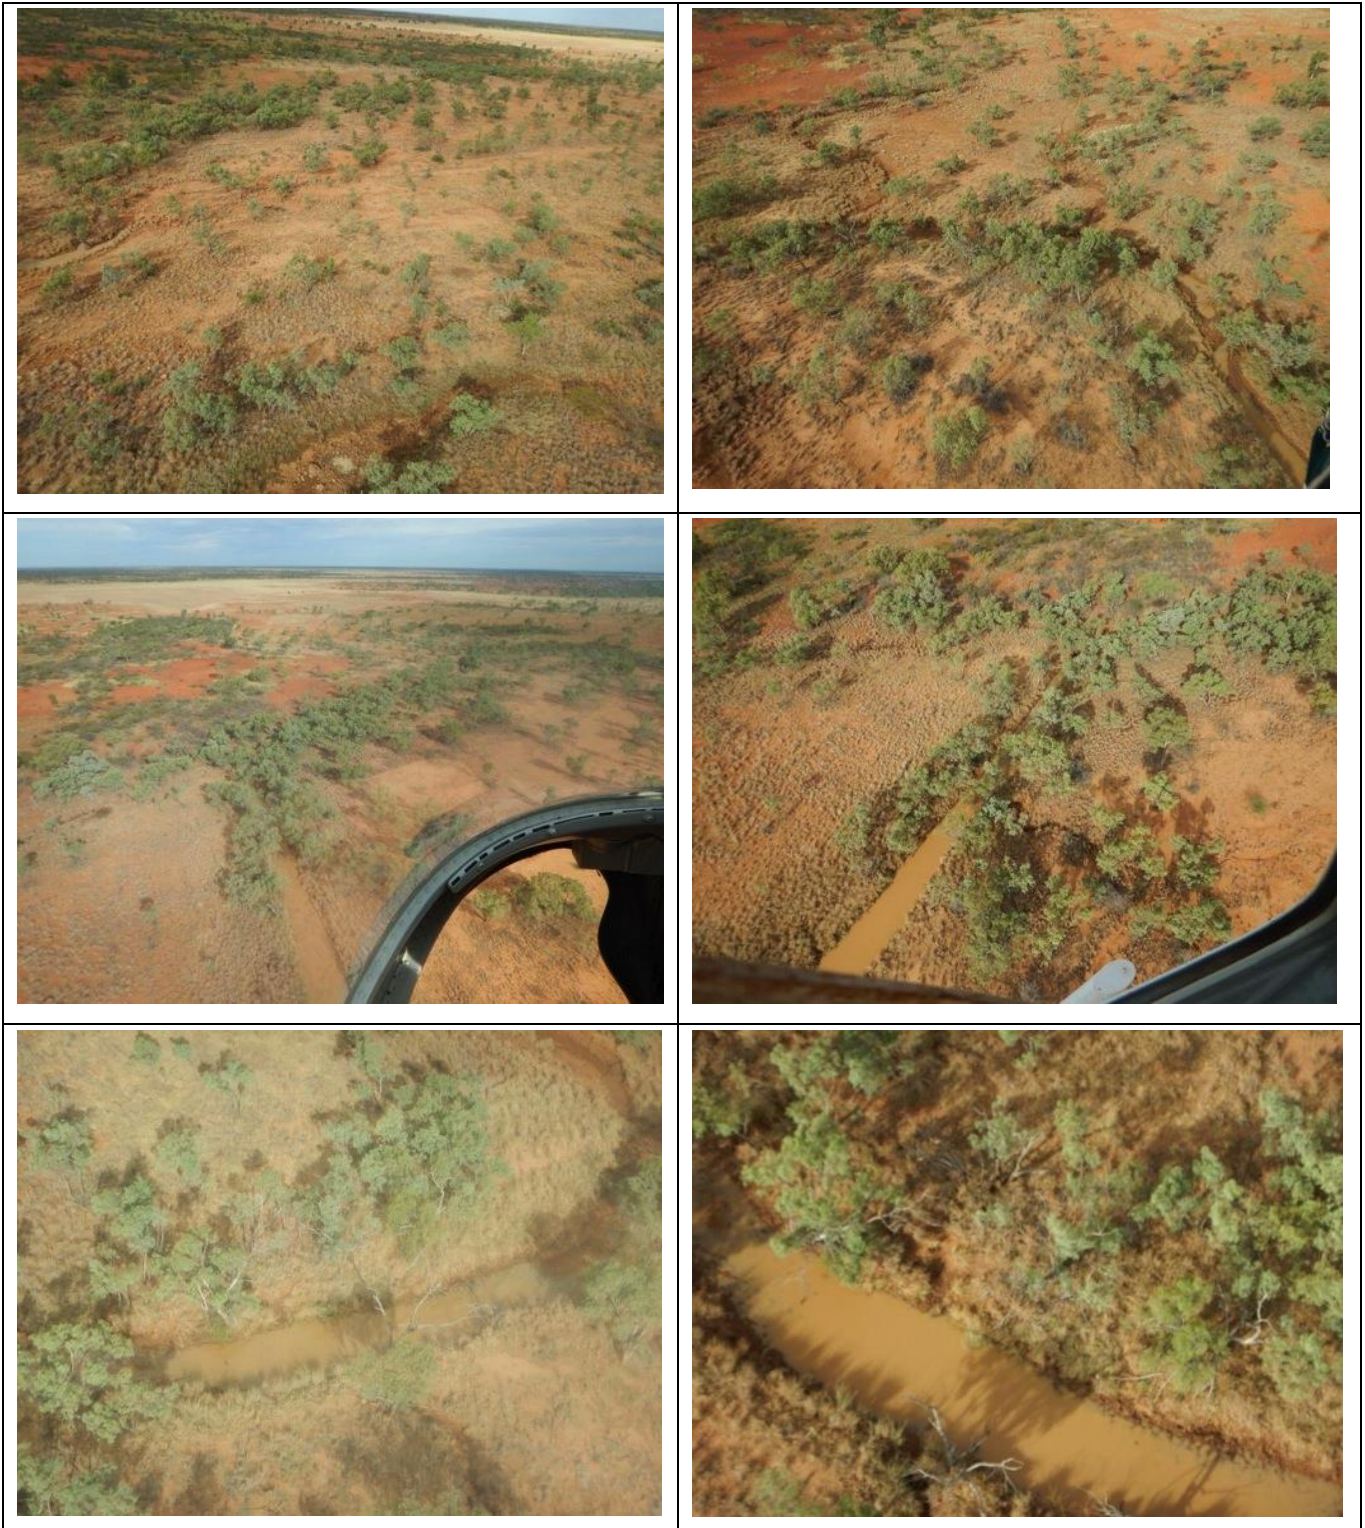
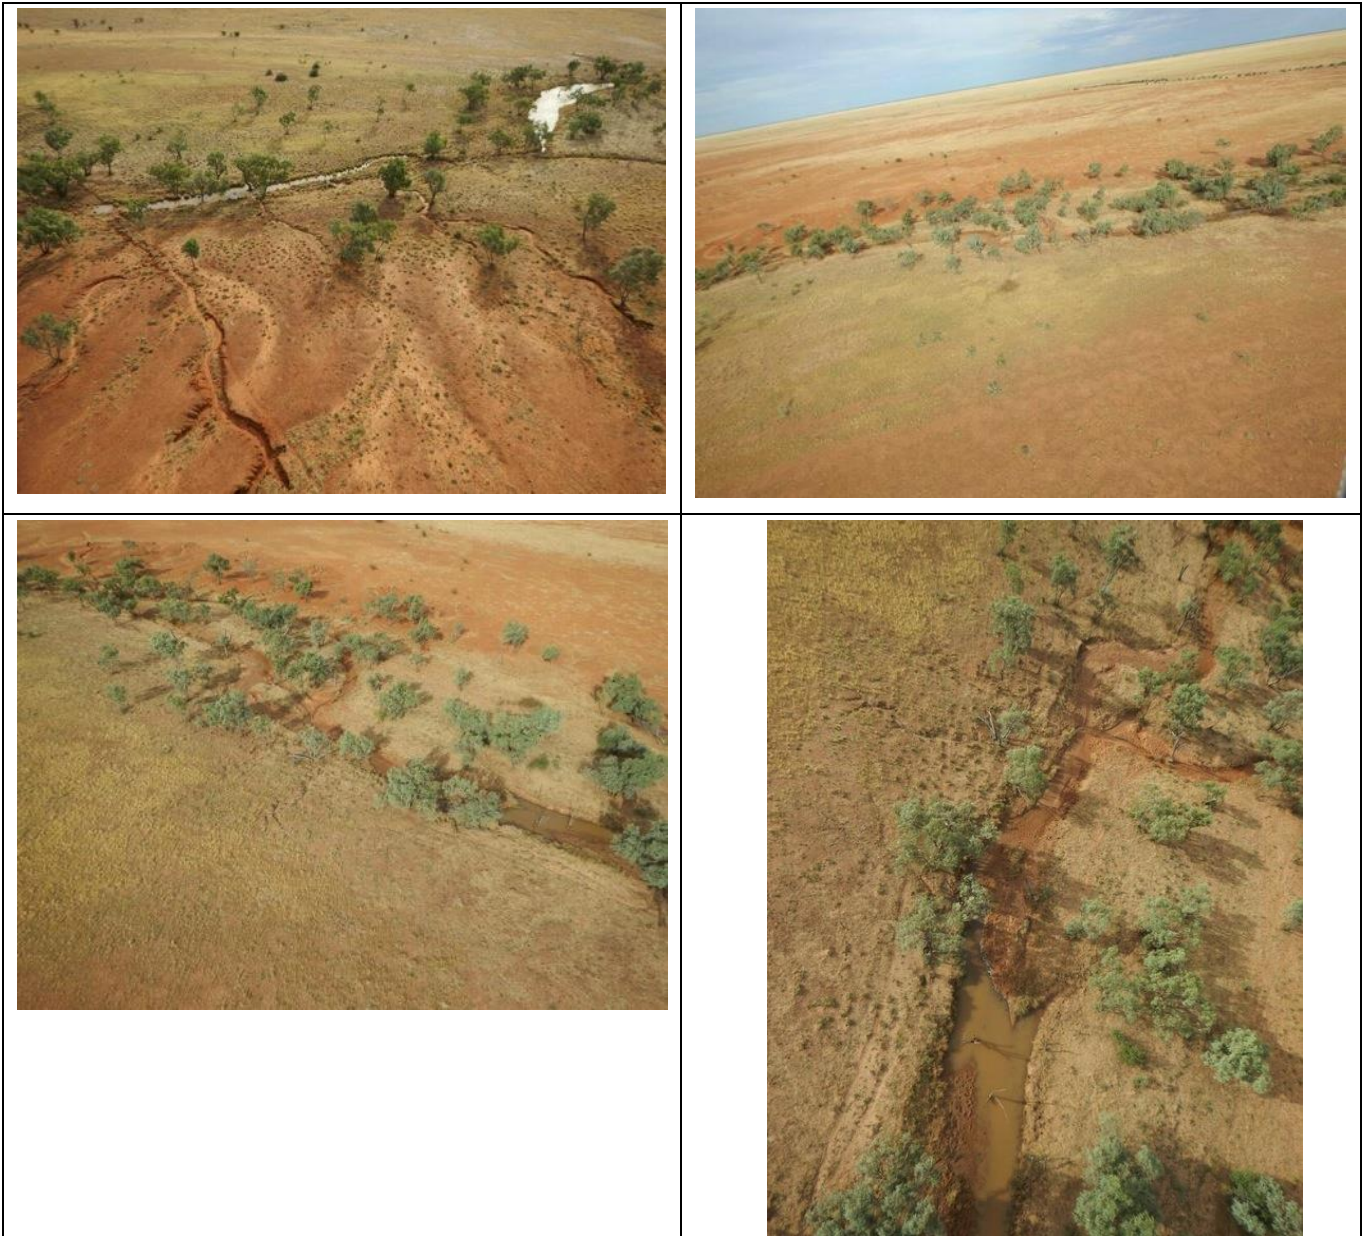
<b>Location</b>							
<b>Site name</b>	Queensland Watercourse 4			<b>Location (KP)</b>	509		
<b>Watercourse name</b>	Polygonum Creek			<b>GPS points GDA 1994, Zone 54</b>	E 0237521 N 7707285		
<b>General</b>							
<b>Stream order</b>	3	<b>Channel type</b>	Single	<b>No. of channels</b>	1	<b>Surrounding landform</b>	Clay / rock
<b>Geometry– N/A aerial survey only</b>							
<b>Bank height (m)</b>		<b>Channel width (m)</b>		<b>Bank slope (%)</b>	> 60	<b>Bank type</b>	Sand / rock
<b>Bed width (m)</b>		<b>Bed slope (%)</b>		<b>Bed type</b>	Earth	<b>Presence of root matter in bank or aquatic vegetation</b>	
<b>Stability– N/A aerial survey only</b>							
<b>Erosion presence</b>	No	<b>Location</b>				<b>Type</b>	
<b>Possible contributing factors</b>						<b>Severity</b>	
<b>Habitat</b>							
<b>Riparian vegetation</b>	<i>Eucalyptus camaldulensis</i> , Spinifex.						
<b>In-stream habitat</b>	Yes, debris, root					<b>Presence of water or signs of wetted embankment</b>

<b>Permanent water (within 1km of ROW)</b>							
<b>Presence of pool</b>		<b>Proximity to ROW crossing (m)</b>		<b>Width of pool (m)</b>		<b>Depth of pool (m)</b>	
<b>Water description</b>				<b>Bank height (m)</b>		<b>Bank width (m)</b>	
<b>Bank slope</b>		<b>Bank composition</b>					<b>Vegetation presence</b>
<b>General notes</b>							
Water present at a number of places, unlikely to persist during the dry season. Rocky surrounds							
<b>Sketch of cross sectional profile</b>							
No sketch							
<b>Photos</b>
