## Northern Gas Pipeline

### Draft Environmental Impact Statement

#### APPENDIX K – WATERCOURSE CROSSING SURVEY REPORT

# Northern Gas Pipeline Watercourse Crossing Survey Report

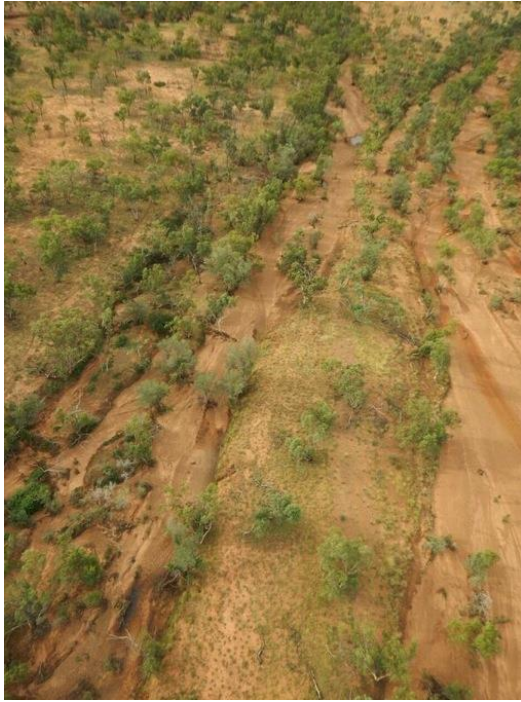
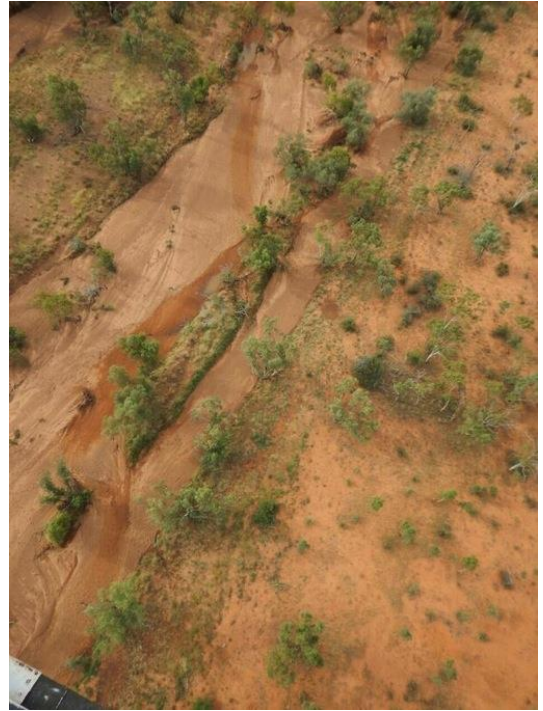
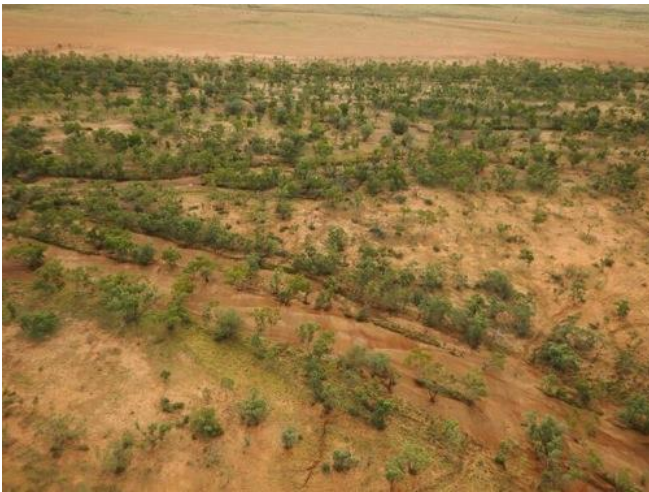
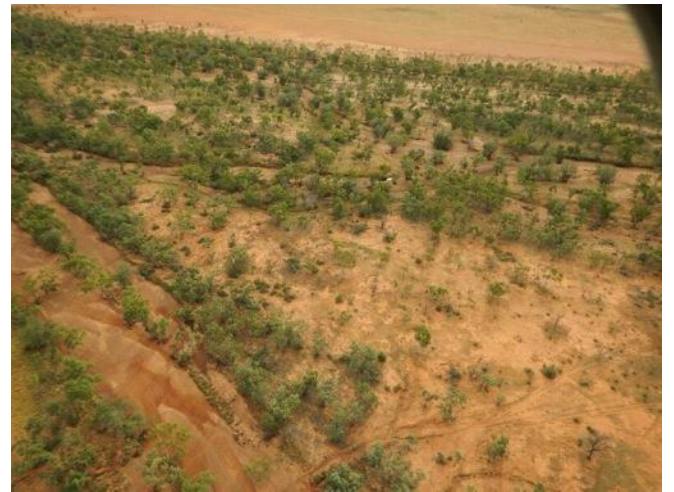
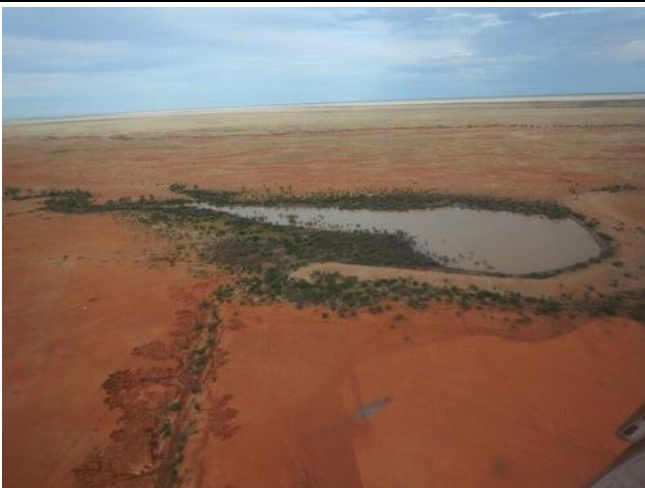
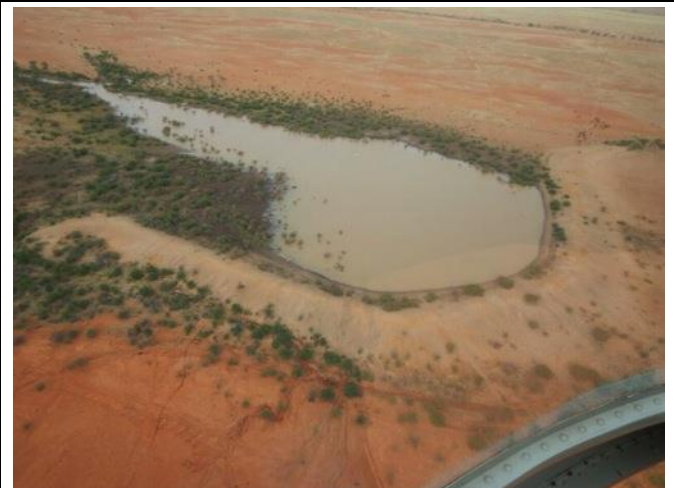
<b>Location</b>							
<b>Site name</b>	Queensland Watercourse 5			<b>Location (KP)</b>		532	
<b>Watercourse name</b>	Templeton River			<b>GPS points GDA 1994, Zone 54</b>		E 0260411 N 7703687	
<b>General</b>							
<b>Stream order</b>	5+	<b>Channel type</b>	Braid	<b>No. of channels</b>		<b>Surrounding landform</b>	Rocky plains
<b>Geometry– N/A aerial survey only</b>							
<b>Bank height (m)</b>		<b>Channel width (m)</b>		<b>Bank slope (%)</b>	See sketch	<b>Bank type</b>	
<b>Bed width (m)</b>		<b>Bed slope (%)</b>		<b>Bed type</b>		<b>Presence of root matter in bank or aquatic vegetation</b>	
<b>Stability– N/A aerial survey only</b>							
<b>Erosion presence</b>		<b>Location</b>				<b>Type</b>	
<b>Possible contributing factors</b>						<b>Severity</b>	
<b>Habitat – N/A aerial survey only</b>							
<b>Riparian vegetation</b>							
<b>In-stream habitat</b>						<b>Presence of water or signs of wetted embankment</b>

<b>Permanent water (within 1km of ROW)</b>							
<b>Presence of pool</b>	Yes*	<b>Proximity to ROW crossing (m)</b>	100	<b>Width of pool (m)</b>		<b>Depth of pool (m)</b>	
<b>Water description</b>				<b>Bank height (m)</b>		<b>Bank width (m)</b>	
<b>Bank slope</b>		<b>Bank composition</b>				<b>Vegetation presence</b>	
<b>General notes</b>							
*Man-made dam. Site was checked for presence of fringing reeds which could indicate suitable habitat for Yellow Chat. None was found.							
<b>Sketch of cross sectional profile</b>							
No sketch							
<b>Photos</b>

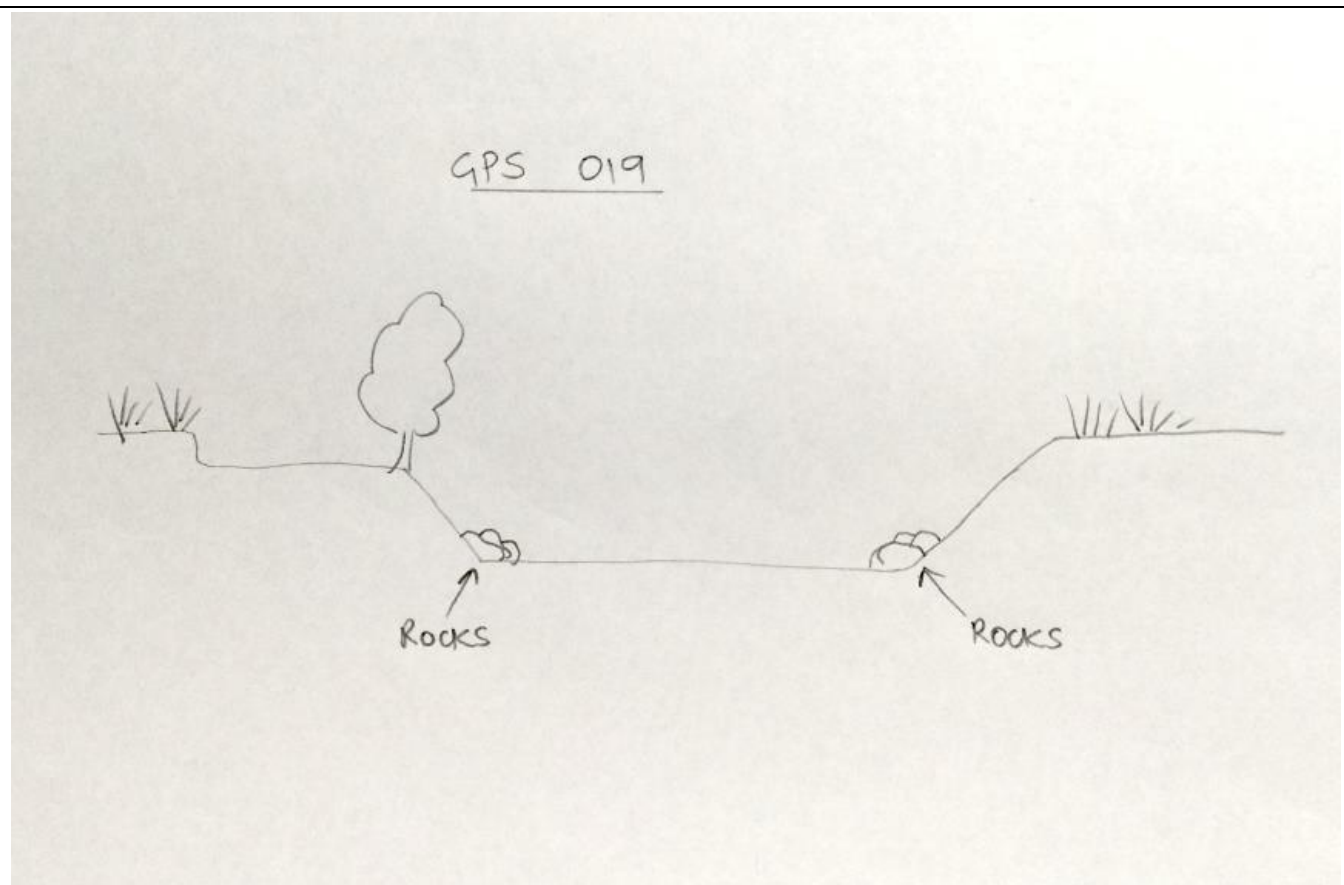
<b>Location</b>							
<b>Site name</b>	Queensland Watercourse 6 (GPS019)			<b>Location (KP)</b>	586		
<b>Watercourse name</b>	Yaringa Creek			<b>GPS points GDA 1994, Zone 54</b>	E 0312403 N 7698545		
<b>General</b>							
<b>Stream order</b>	3	<b>Channel type</b>	Single	<b>No. of channels</b>	1	<b>Surrounding landform</b>	Grassland
<b>Geometry</b>							
<b>Bank height (m)</b>	0.6 – 0.8	<b>Channel width (m)</b>	5	<b>Bank slope (%)</b>	> 45	<b>Bank type</b>	Rock / earth
<b>Bed width (m)</b>	5	<b>Bed slope (%)</b>	Flat	<b>Bed type</b>	Sand	<b>Presence of root matter in bank or aquatic vegetation</b>	Yes
<b>Stability</b>							
<b>Erosion presence</b>	Yes	<b>Location</b>	Bank		<b>Type</b>		
<b>Possible contributing factors</b>			Undercutting		<b>Severity</b>	Mild	
<b>Habitat</b>							
<b>Riparian vegetation</b>	River Red Gum						
<b>In-stream habitat</b>	Roots, rocks				<b>Presence of water or signs of wetted embankment</b>	No

<b>Permanent water (within 1km of ROW)</b>							
<b>Presence of pool</b>	No	<b>Proximity to ROW crossing (m)</b>		<b>Width of pool (m)</b>		<b>Depth of pool (m)</b>	
<b>Water description</b>				<b>Bank height (m)</b>		<b>Bank width (m)</b>	
<b>Bank slope</b>		<b>Bank composition</b>				<b>Vegetation presence</b>	
<b>Sketch of cross sectional profile</b>

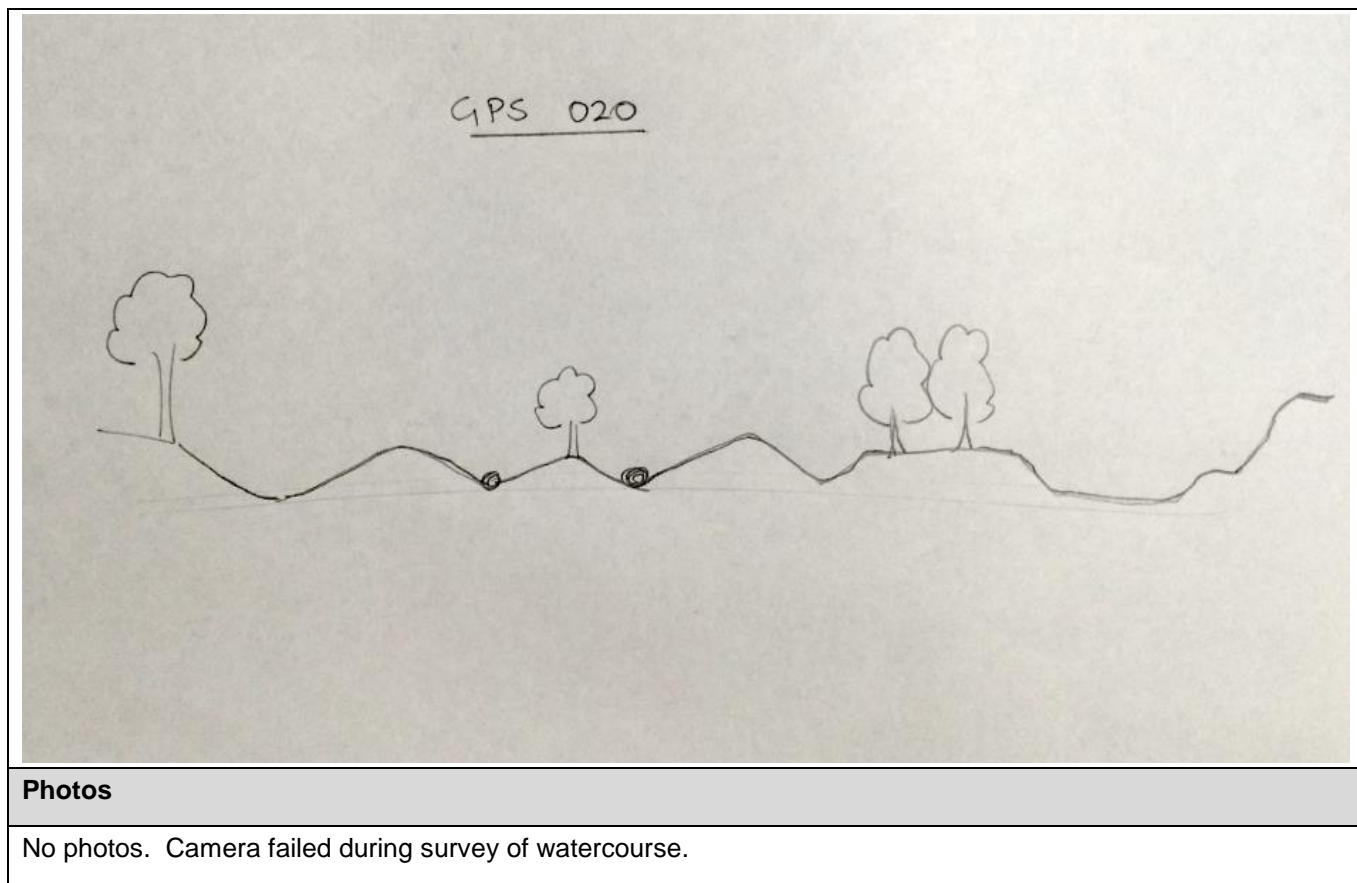
<b>Location</b>							
<b>Site name</b>	Queensland Watercourse 7 (GPS020)				<b>Location (KP)</b>	591	
<b>Watercourse name</b>	Yaringa Creek				<b>GPS points GDA 1994, Zone 54</b>	E 0316311 N 7696264	
<b>General</b>							
<b>Stream order</b>	5+	<b>Channel type</b>	Braided	<b>No. of channels</b>	> 5	<b>Surrounding landform</b>	Rocky plains
<b>Geometry</b>							
<b>Bank height (m)</b>	0.6 – 0.8	<b>Channel width (m)</b>	~ 50	<b>Bank slope (%)</b>	80	<b>Bank type</b>	Earth / sand
<b>Bed width (m)</b>	30	<b>Bed slope (%)</b>	Flat	<b>Bed type</b>	Sand	<b>Presence of root matter in bank or aquatic vegetation</b>	Yes
<b>Stability</b>							
<b>Erosion presence</b>	Yes	<b>Location</b>	Bank			<b>Type</b>	Gully
<b>Possible contributing factors</b>			Cattle			<b>Severity</b>	Minor
<b>Habitat</b>							
<b>Riparian vegetation</b>	E. camaldulensis, C. terminalis						
<b>In-stream habitat</b>	Roots, debris, veg					<b>Presence of water or signs of wetted embankment</b>	No

<b>Permanent water (within 1km of ROW)</b>							
<b>Presence of pool</b>	No	<b>Proximity to ROW crossing (m)</b>		<b>Width of pool (m)</b>		<b>Depth of pool (m)</b>	
<b>Water description</b>					<b>Bank height (m)</b>		<b>Bank width (m)</b>
<b>Bank slope</b>		<b>Bank composition</b>					<b>Vegetation presence</b>
<b>Sketch of cross sectional profile</b>

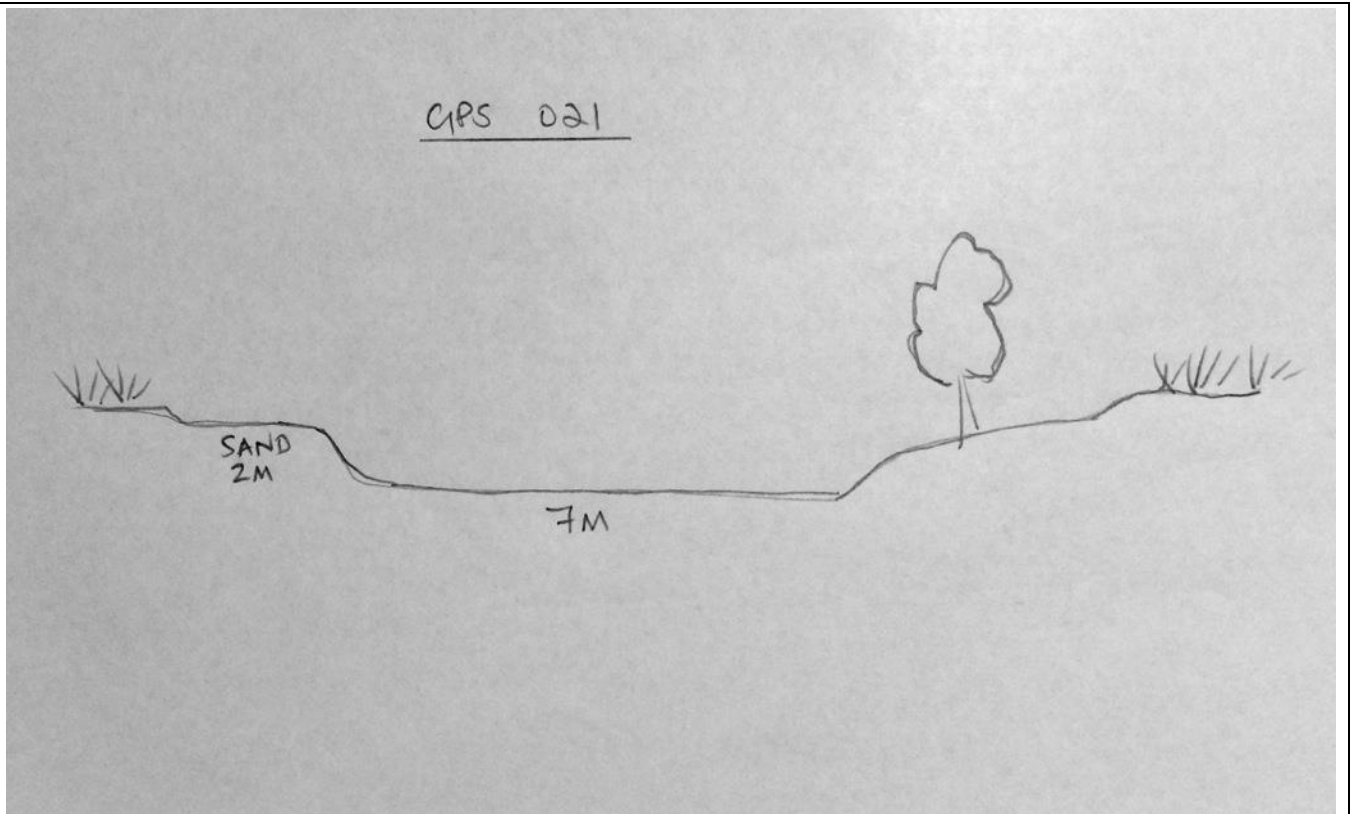
<b>Location</b>									
<b>Site name</b>	Queensland Watercourse 8 (GPS021)				<b>Location (KP)</b>		598		
<b>Watercourse name</b>	Yaringa Creek				<b>GPS points GDA 1994, Zone 54</b>		E 0323574 N 7695744		
<b>General</b>									
<b>Stream order</b>	-	<b>Channel type</b>	Single	<b>No. of channels</b>	1	<b>Surrounding landform</b>	Rocky plain		
<b>Geometry</b>									
<b>Bank height (m)</b>	0.5	<b>Channel width (m)</b>	9	<b>Bank slope (%)</b>	~ 45	<b>Bank type</b>	Earth / sand		
<b>Bed width (m)</b>	7	<b>Bed slope (%)</b>	Flat	<b>Bed type</b>	Sand / gravel	<b>Presence of root matter in bank or aquatic vegetation</b>			Yes
<b>Stability</b>									
<b>Erosion presence</b>	Yes	<b>Location</b>	Bank - undercut			<b>Type</b>			
<b>Possible contributing factors</b>						<b>Severity</b>	Mild		
<b>Habitat</b>									
<b>Riparian vegetation</b>	<i>E. camaldulensis</i> , Buffel Grass, Black Spear Grass, <i>Themeda</i> sp.

<b>In-stream habitat</b>	Yes – roots, debris, rock					<b>Presence of water or signs of wetted embankment</b>		No	
<b>Permanent water (within 1km of ROW)</b>									
<b>Presence of pool</b>	No	<b>Proximity to ROW crossing (m)</b>		<b>Width of pool (m)</b>		<b>Depth of pool (m)</b>			
<b>Water description</b>					<b>Bank height (m)</b>		<b>Bank width (m)</b>		
<b>Bank slope</b>		<b>Bank composition</b>					<b>Vegetation presence</b>		
<b>Sketch of cross sectional profile</b>

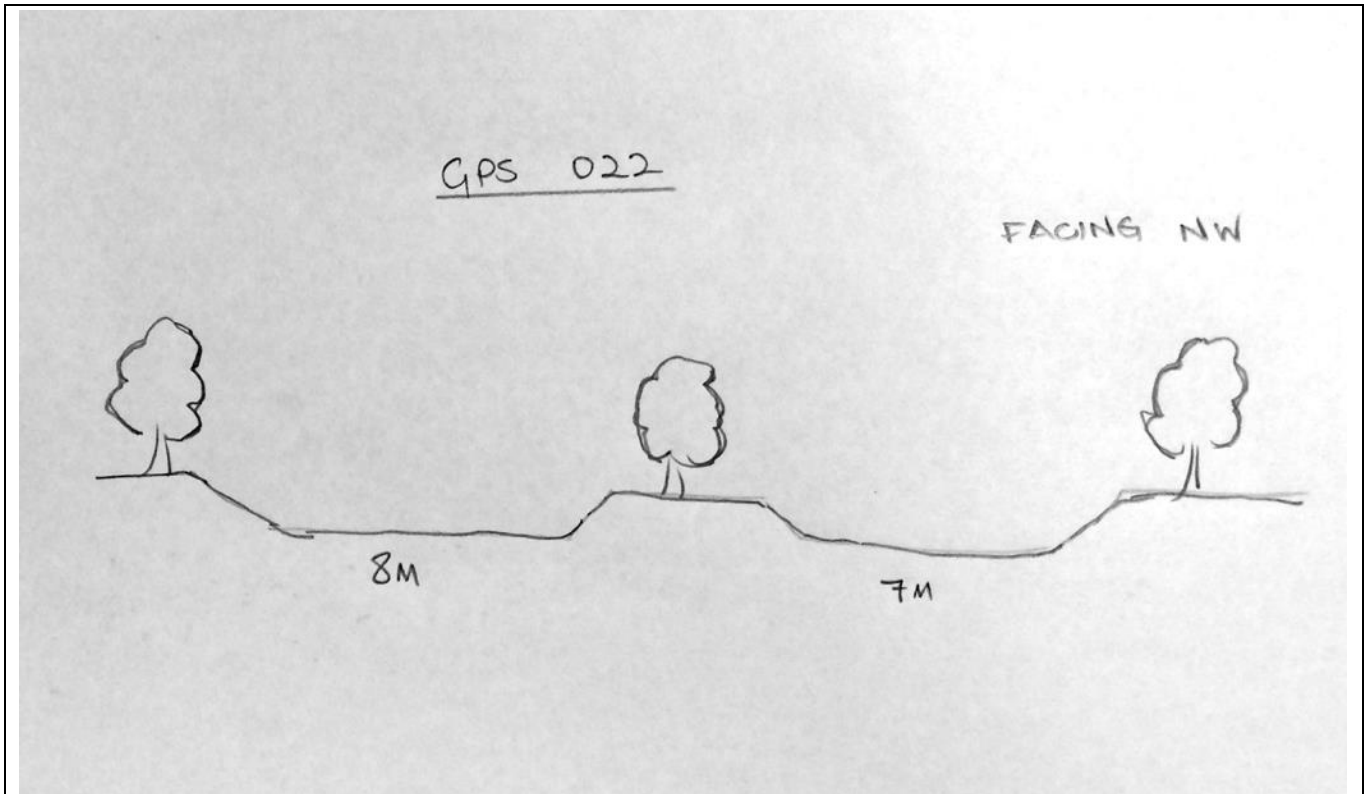
<b>Location</b>							
<b>Site name</b>	Queensland Watercourse 9 (GPS022)			<b>Location (KP)</b>	602		
<b>Watercourse name</b>	Yaringa Creek			<b>GPS points GDA 1994, Zone 54</b>	E 0327567 N 7695639		
<b>General</b>							
<b>Stream order</b>		<b>Channel type</b>	Braided	<b>No. of channels</b>		<b>Surrounding landform</b>	Rocky / sandy plain
<b>Geometry</b>							
<b>Bank height (m)</b>	0.8 - 1	<b>Channel width (m)</b>	8, 7	<b>Bank slope (%)</b>	60	<b>Bank type</b>	Earth
<b>Bed width (m)</b>		<b>Bed slope (%)</b>		<b>Bed type</b>	Sand / gravel	<b>Presence of root matter in bank or aquatic vegetation</b>	Yes
<b>Stability</b>							
<b>Erosion presence</b>	No	<b>Location</b>			<b>Type</b>		
<b>Possible contributing factors</b>					<b>Severity</b>		
<b>Habitat</b>							
<b>Riparian vegetation</b>	River Red Gum, Buffel Grass, Black Spear Grass						
<b>In-stream habitat</b>	Veg, branches, roots, debris				<b>Presence of water or signs of wetted embankment</b>	Yes

<b>Permanent water (within 1km of ROW)</b>							
<b>Presence of pool</b>	No	<b>Proximity to ROW crossing (m)</b>		<b>Width of pool (m)</b>		<b>Depth of pool (m)</b>	
<b>Water description</b>				<b>Bank height (m)</b>		<b>Bank width (m)</b>	
<b>Bank slope</b>		<b>Bank composition</b>				<b>Vegetation presence</b>	
<b>General notes</b>							
No permanent water – water within creek bed from rain. Multiple >10, all < 10 cm deep at crossing point.							
<b>Sketch of cross sectional profile</b>

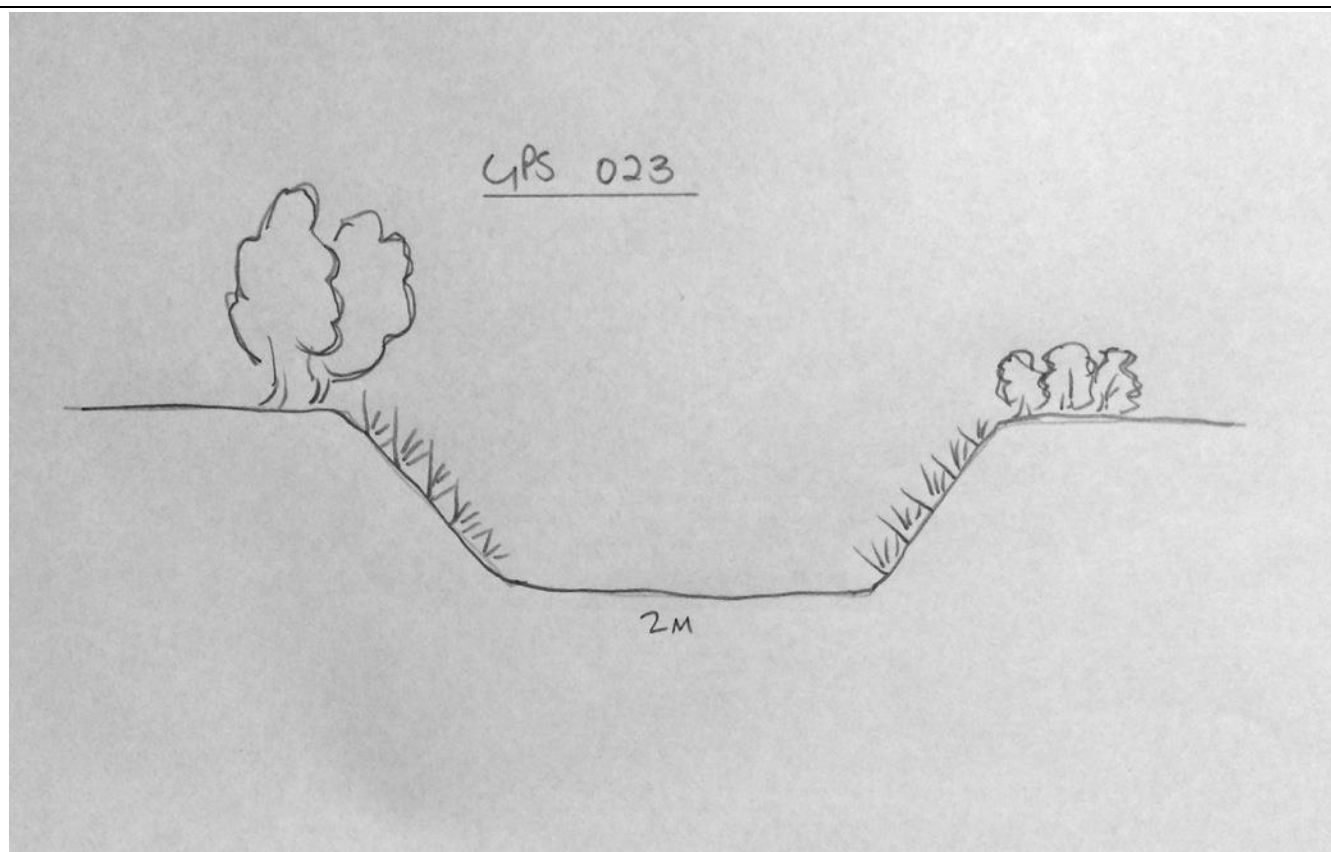
<b>Location</b>							
<b>Site name</b>	Queensland Watercourse 10 (GPS023)			<b>Location (KP)</b>	607		
<b>Watercourse name</b>	Unnamed, tributary of the Templeton River			<b>GPS points GDA 1994, Zone 54</b>	E 0330539 N 7697820		
<b>General</b>							
<b>Stream order</b>	1-2	<b>Channel type</b>	Single	<b>No. of channels</b>	1	<b>Surrounding landform</b>	Rocky plains
<b>Geometry</b>							
<b>Bank height (m)</b>	0.6. – 0.8	<b>Channel width (m)</b>	2	<b>Bank slope (%)</b>	60	<b>Bank type</b>	Earth / rock
<b>Bed width (m)</b>	2	<b>Bed slope (%)</b>	-	<b>Bed type</b>	Sand	<b>Presence of root matter in bank or aquatic vegetation</b>	Yes
<b>Stability</b>							
<b>Erosion presence</b>	No	<b>Location</b>				<b>Type</b>	
<b>Possible contributing factors</b>						<b>Severity</b>	
<b>Habitat</b>							
<b>Riparian vegetation</b>	<i>E. leucophylla</i> , Buffel Grass, <i>Themeda</i> sp.						
<b>In-stream habitat</b>	No					<b>Presence of water or signs of wetted embankment</b>	No

<b>Permanent water (within 1km of ROW)</b>							
<b>Presence of pool</b>	No	<b>Proximity to ROW crossing (m)</b>		<b>Width of pool (m)</b>		<b>Depth of pool (m)</b>	
<b>Water description</b>				<b>Bank height (m)</b>		<b>Bank width (m)</b>	
<b>Bank slope</b>		<b>Bank composition</b>					<b>Vegetation presence</b>
<b>Sketch of cross sectional profile</b>

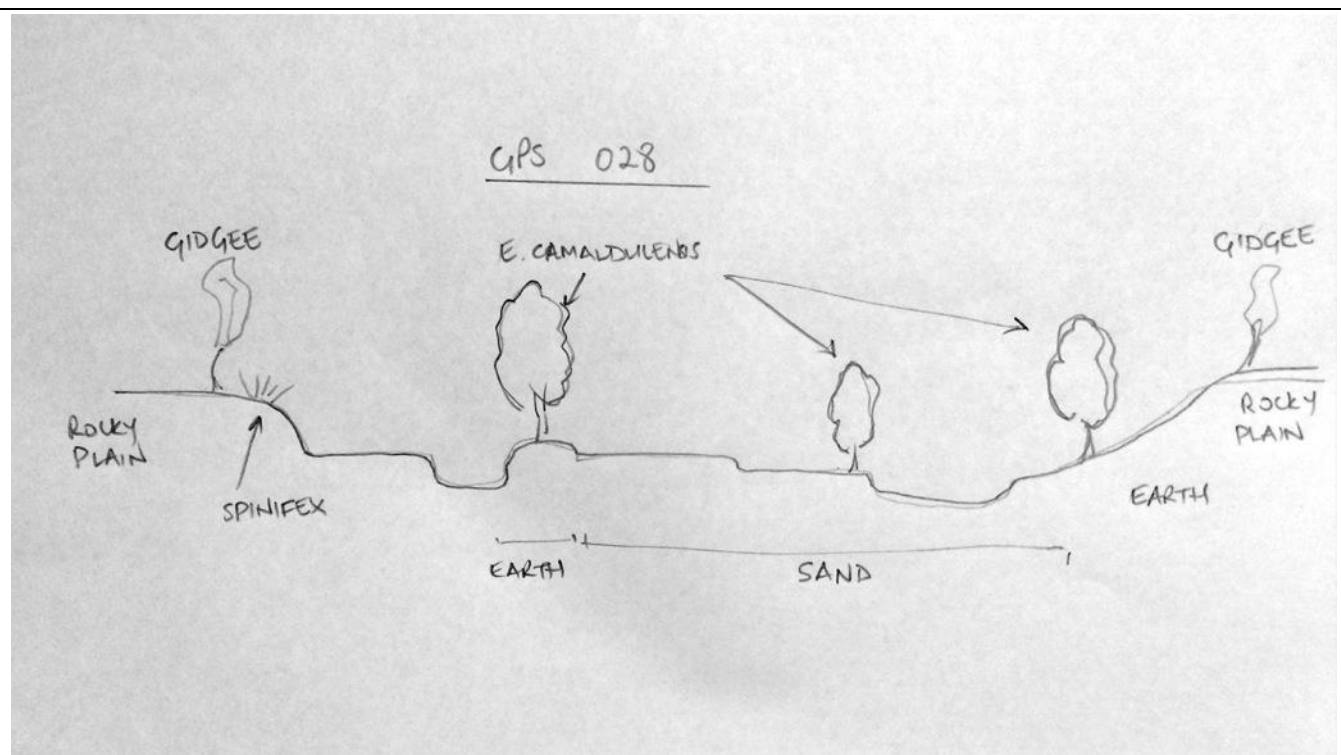
<b>Location</b>							
<b>Site name</b>	Queensland Watercourse 11 (GPS028)			<b>Location (KP)</b>	614		
<b>Watercourse name</b>	Mica Creek			<b>GPS points GDA 1994, Zone 54</b>	E 0337679 N 7696802		
<b>General</b>							
<b>Stream order</b>	2	<b>Channel type</b>	Single	<b>No. of channels</b>	1	<b>Surrounding landform</b>	Rocky plains
<b>Geometry</b>							
<b>Bank height (m)</b>	1	<b>Channel width (m)</b>	11	<b>Bank slope (%)</b>	50	<b>Bank type</b>	Gravel / sand
<b>Bed width (m)</b>	18	<b>Bed slope (%)</b>	< 5	<b>Bed type</b>	Sand gravel	<b>Presence of root matter in bank or aquatic vegetation</b>	Yes
<b>Stability</b>							
<b>Erosion presence</b>	Yes	<b>Location</b>	Bank / gully near crossing			<b>Type</b>	Gully Undercut
<b>Possible contributing factors</b>			Cattle, vehicles, runoff from side streams			<b>Severity</b>	Medium
<b>Habitat</b>							
<b>Riparian vegetation</b>	<i>Eucalyptus camaldulensis</i> , gidgee, Buffel Grass (grazed), some Mistletoe (scattered), <i>E. leucophylla</i> (back from bank)

<b>In-stream habitat</b>	Roots, debris, stones (to 30 cm), fallen logs					<b>Presence of water or signs of wetted embankment</b>	Yes
<b>Permanent water (within 1km of ROW)</b>							
<b>Presence of pool</b>	No	<b>Proximity to ROW crossing (m)</b>		<b>Width of pool (m)</b>		<b>Depth of pool (m)</b>	
<b>Water description</b>				<b>Bank height (m)</b>		<b>Bank width (m)</b>	
<b>Bank slope</b>		<b>Bank composition</b>				<b>Vegetation presence</b>	
<b>General notes</b>							
Would likely form more channels in wet season, running water just upstream at time of survey							
<b>Sketch of cross sectional profile</b>

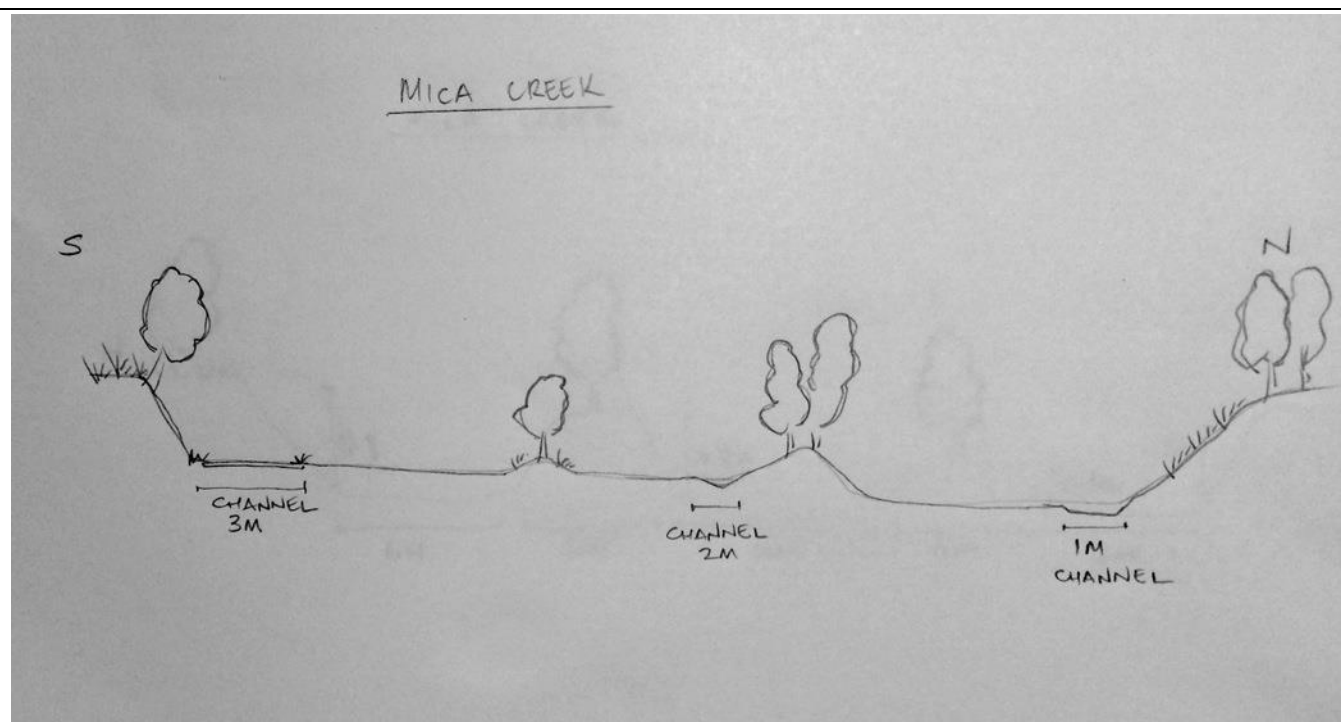
<b>Location</b>							
<b>Site name</b>	Queensland Watercourse 15 (Mica Creek)			<b>Location (KP)</b>	617		
<b>Watercourse name</b>	Mica Creek			<b>GPS points GDA 1994, Zone 54</b>	E0339926 N7696881		
<b>General</b>							
<b>Stream order</b>	4	<b>Channel type</b>	Braided	<b>No. of channels</b>	3	<b>Surrounding landform</b>	Rocky / sandy plains near rocky hills
<b>Geometry</b>							
<b>Bank height (m)</b>	~ 1.5	<b>Channel width (m)</b>	3, 2, 1	<b>Bank slope (%)</b>	N – 45 S – 60	<b>Bank type</b>	Sand
<b>Bed width (m)</b>	~ 42	<b>Bed slope (%)</b>	Flat	<b>Bed type</b>	Sand / gravel	<b>Presence of root matter in bank or aquatic vegetation</b>	Yes
<b>Stability</b>							
<b>Erosion presence</b>	Yes	<b>Location</b>	Bank (both sides)			<b>Type</b>	Gully
<b>Possible contributing factors</b>			Runoff from surrounding lands and cattle			<b>Severity</b>	Moderate
<b>Habitat</b>							
<b>Riparian vegetation</b>	<i>Eucalyptus camaldulensis</i> to <i>E. leucophylla</i> behind, Buffel Grass underneath, isolated native grasses

<b>In-stream habitat</b>	Debris, roots, rocks to 50 cm					<b>Presence of water or signs of wetted embankment</b>	Yes
<b>Presence of water</b>							
<b>Flowing</b>	No flowing water						
<b>Presence of pool</b>	Yes	<b>Proximity to ROW crossing (m)</b>	20	<b>Width of pool (m)</b>	5 x 2	<b>Depth of pool (m)</b>	0.20
<b>Water description</b>	Dark / tannins			<b>Bank height (m)</b>	-	<b>Bank width (m)</b>	-
<b>Bank slope</b>	-	<b>Bank composition</b>	Sand			<b>Vegetation presence</b>	-
<b>General notes</b>							
Pool was small and unlikely to remain throughout dry season – not a permanent pool. Pool was near Mica Creek road crossing, and contained numerous fish.							
<b>Sketch of cross sectional profile</b>

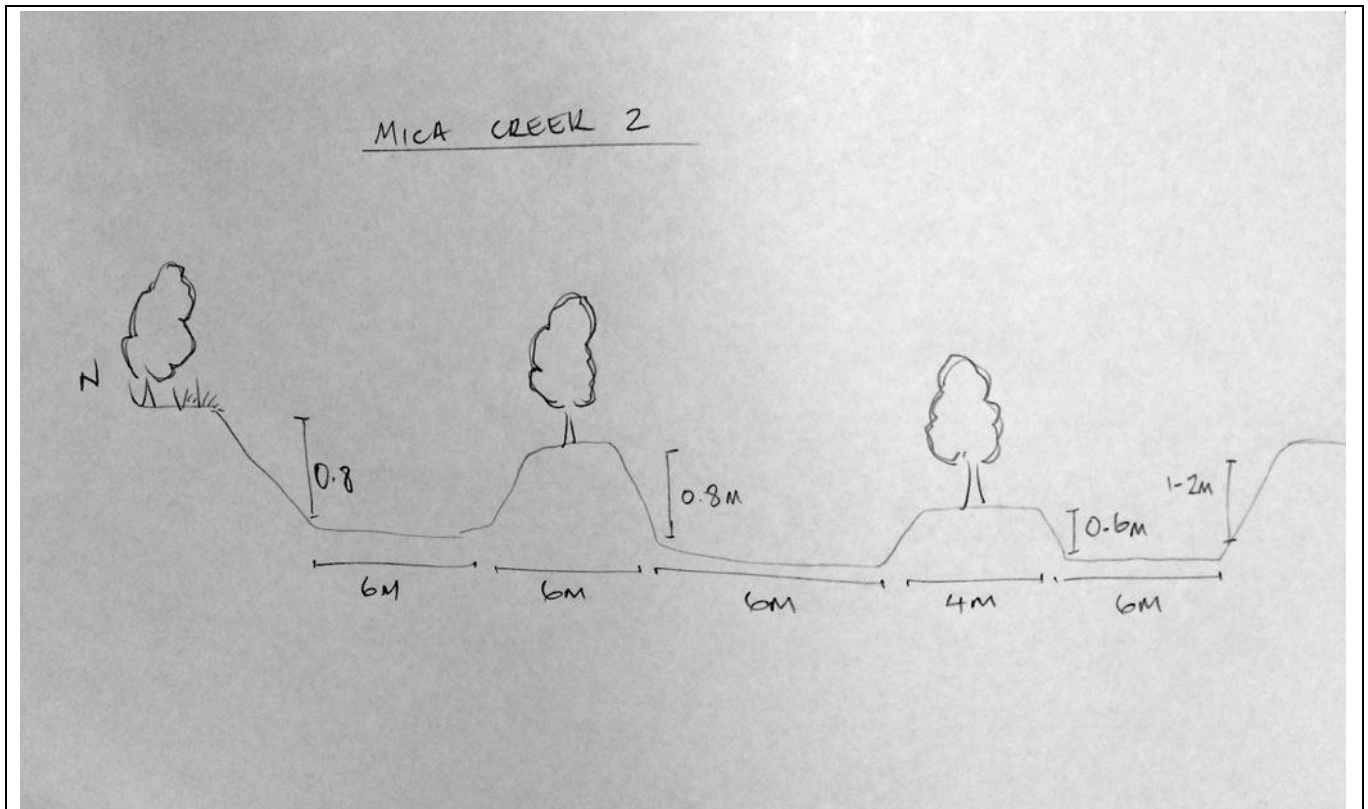
<b>Location</b>									
<b>Site name</b>	Queensland Watercourse 14 (Mica Creek 2)				<b>Location (KP)</b>		617		
<b>Watercourse name</b>	Mica Creek				<b>GPS points GDA 1994, Zone 53 or 54</b>		E 0339916 N 7696929		
<b>General</b>									
<b>Stream order</b>	4	<b>Channel type</b>	Braided	<b>No. of channels</b>	3	<b>Surrounding landform</b>	Sandy/rocky plains		
<b>Geometry</b>									
<b>Bank height (m)</b>	0.8 – 1.2	<b>Channel width (m)</b>	6, 6, 6	<b>Bank slope (%)</b>	60	<b>Bank type</b>	Sand / gravel		
<b>Bed width (m)</b>	~ 27	<b>Bed slope (%)</b>	Flat	<b>Bed type</b>	Sand / gravel	<b>Presence of root matter in bank or aquatic vegetation</b>			Yes
<b>Stability</b>									
<b>Erosion presence</b>	Yes	<b>Location</b>	North bank			<b>Type</b>	Gully		
<b>Possible contributing factors</b>			Cattle tracks on bank and in stream bed			<b>Severity</b>	Moderate		
<b>Habitat</b>									
<b>Riparian vegetation</b>	<i>Eucalyptus camaldulensis</i> , with <i>E. leucophylla</i> and gidgee back from bank <i>Acacia chisholmii</i> and predominantly Buffel Grass, spinifex away from river

<b>In-stream habitat</b>	Debris, roots, rocks					<b>Presence of water or signs of wetted embankment</b>		Yes	
<b>Permanent water (within 1km of ROW)</b>									
<b>Presence of pool</b>	No	<b>Proximity to ROW crossing (m)</b>		<b>Width of pool (m)</b>		<b>Depth of pool (m)</b>			
<b>Water description</b>					<b>Bank height (m)</b>		<b>Bank width (m)</b>		
<b>Bank slope</b>		<b>Bank composition</b>					<b>Vegetation presence</b>		
<b>Sketch of cross sectional profile</b>
